Chapter 9

Historic Neighborhood Commercial Buildings

Chapter 10

Boulevard Park Historic District

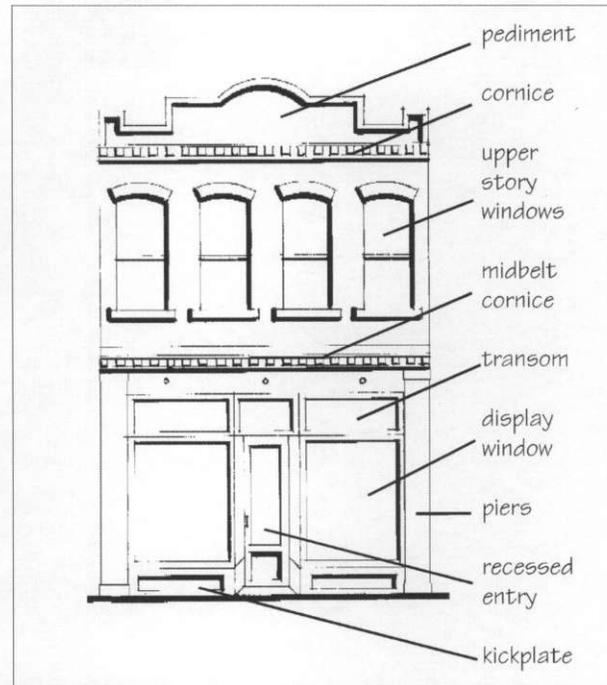
Typical commercial components.

9.1 For a commercial storefront building, a rehabilitation project may include the preservation of these character-defining elements:

- **Display windows:** The main portion of glass on the storefront, where goods and services are displayed, and the original framing and trim elements.

- **Transom:** The upper portion of the storefront, separated from the main display window by a frame.

- **Kickplate:** Found beneath the display window. Sometimes called a bulkhead panel. There may also be a continuous base of a more durable material, such as stone around the exterior of the building.

- **Entry:** Usually set back from the sidewalk in a protected recess.
- **Upper-story windows:** Windows located above the street level. These usually have a vertical orientation, and appear to be less transparent than the large expanse of glass in the storefront below.
- **Cornice molding:** A decorative projecting band at the top of the building. A **midbelt cornice** may sometimes be found separating some floors.

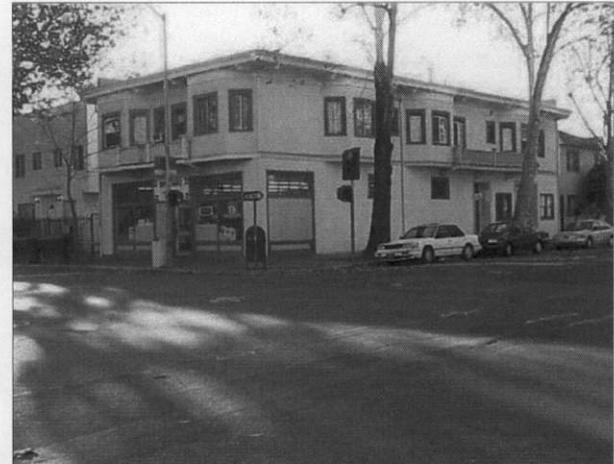
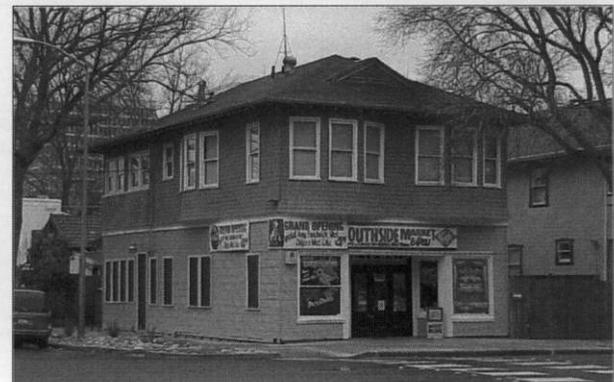
Corner stores are strong components of many historic residential neighborhoods.

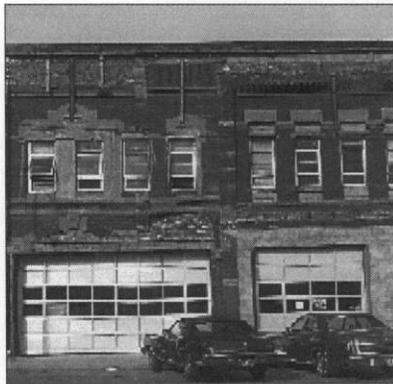
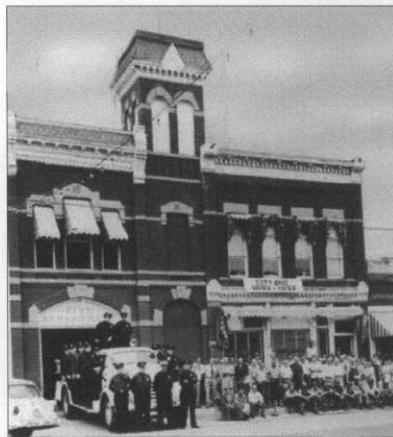
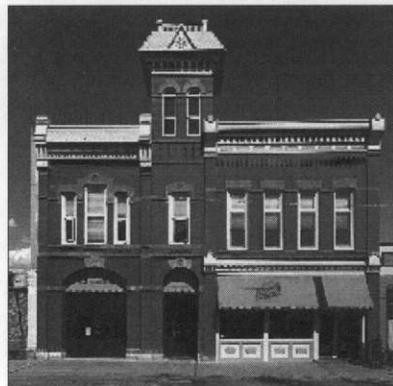
This storefront facade (bottom image) was restored to its original character with the help of historic photographs (middle image) after being altered over time (top image). The rehabilitation preserved surviving details and reconstructed missing ones.

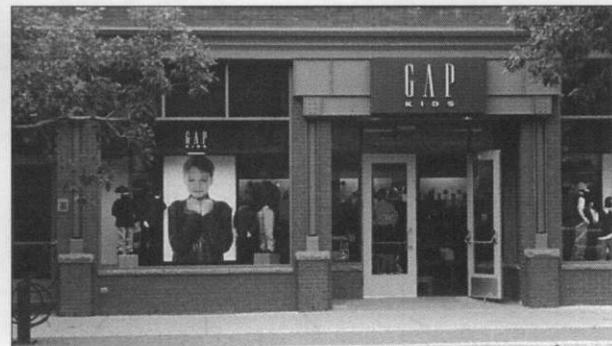
Where original details are missing, an alternative design that is a contemporary interpretation of a traditional storefront, as this one is, may be considered. The storefront still should be designed to provide interest to pedestrians.

9.8 An alternative design that is a contemporary interpretation of a traditional storefront is appropriate, if the original design is unknown.

- Where the original is missing and no evidence of its character exists, a new design that uses the traditional elements may be considered.
- However, the new design must continue to convey the characteristics of typical storefronts, including the transparent character of the display windows, recessed entries and cornices, to name a few.
- Altering the size of a historic window opening or blocking it with opaque materials is not appropriate. Retain the size and dimensions of historic window openings. Retain glazing and transparency where they were found historically.
- Note that in some cases an original storefront may have been altered early in the history of the building and the alterations have taken on significance. Such changes should be preserved.

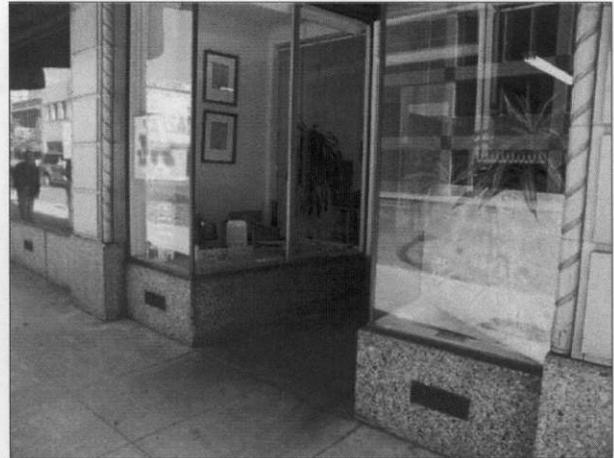
Maintain recessed entries where they are found.

9.12 Maintain recessed entries where they are found.

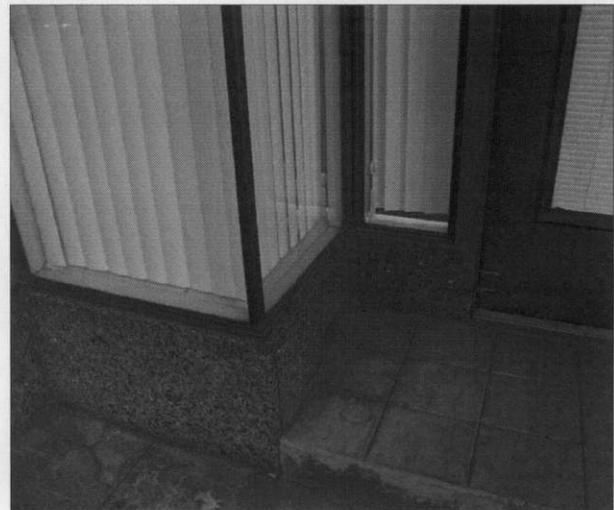
If the original kickplate is missing, develop a sympathetic replacement design. Here a transparent glass kickplate is used where a solid panel may have existed. However, the original proportions are still conveyed, which is appropriate.

9.15 If the original kickplate is missing, develop a sympathetic replacement design.

- Wood, metal and masonry are appropriate materials for replacements.
- Coordinate the color of the kickplate with other trim elements on the building.

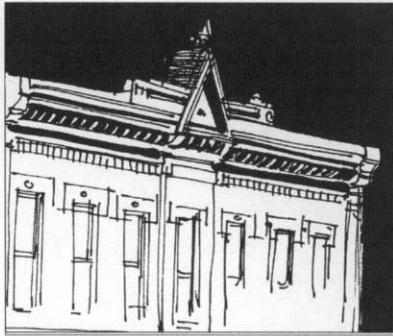
Reconstruct a missing cornice when historic evidence is available.

9.17 Reconstruct a missing cornice, when historic evidence is available.

- Use early photographs to determine design details of an original cornice.
- The substitution of another old cornice for the original may be considered, provided that the substitute is similar in appearance to the original.

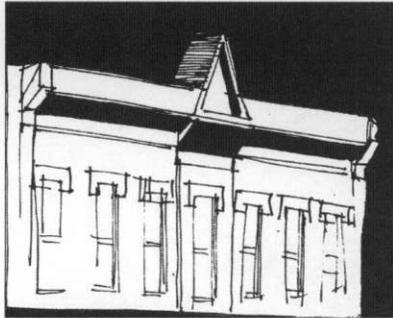
A simplified interpretation also is appropriate if documentation of the original design is missing.

9.18 A simplified interpretation also is appropriate if evidence of the original is missing.

- Appropriate materials include stone, brick and stamped metal. Concrete and resin cast products may also be used.

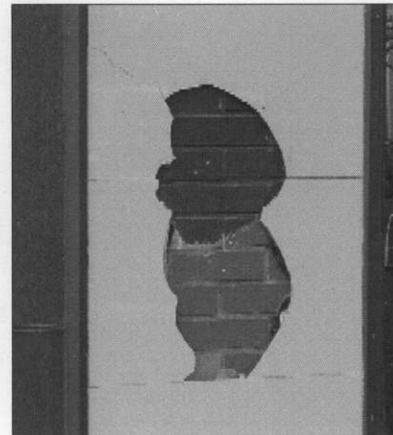
Expose original material if it has been covered.

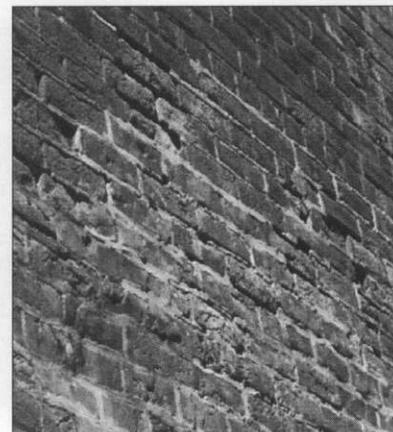
Protect masonry from water deterioration.

9.21 Protect masonry from water deterioration.

- Provide proper drainage so water does not stand on flat surfaces or accumulate in decorative features.
- Provide a means to drain water away from foundations to minimize rising damp. Do not permit downspouts to direct water to the foundation.
- DO NOT use a sealant, or clear coat, to protect masonry. A sealant will prevent proper breathing and cause moisture to be trapped inside the masonry.
- However, if masonry was painted historically, then it may be appropriate to repaint.

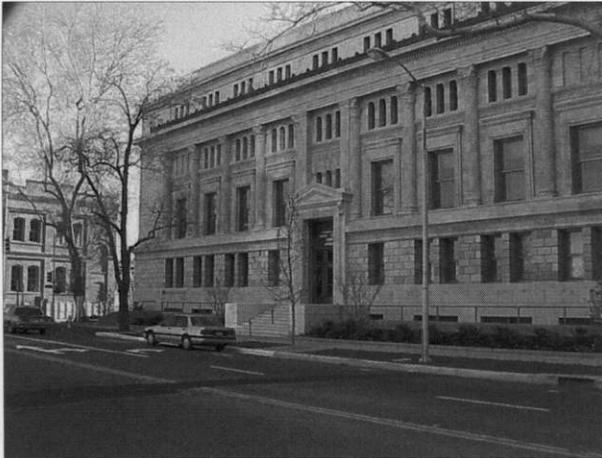
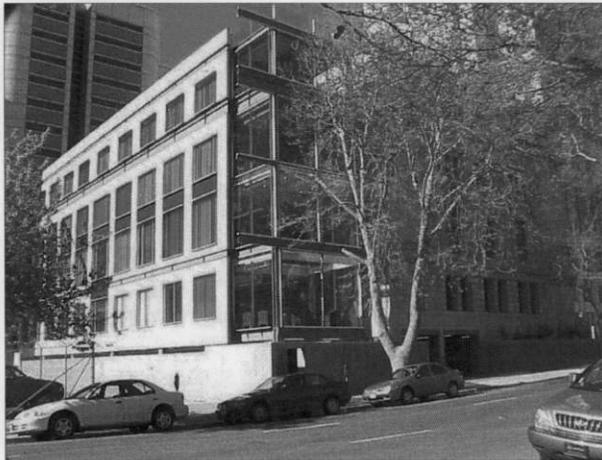
New addition with minimal impact to historic structure.

9.25 An addition should not damage or obscure historically or architecturally important features.

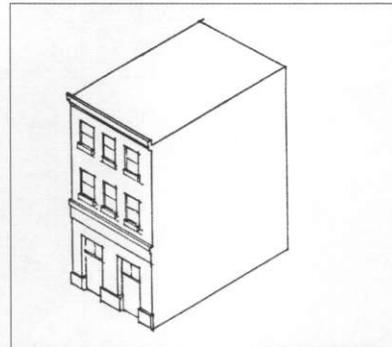
An original three-story building, before an addition. (Compare with sketches below and on the following page.)

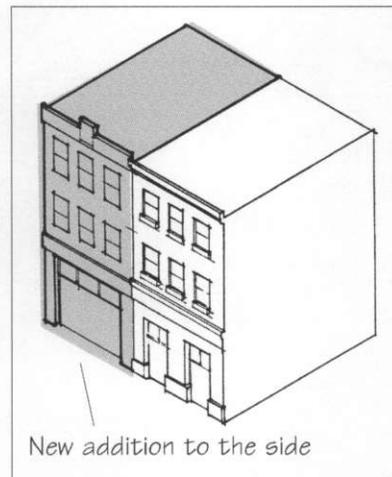
New addition to the side

9.28 An addition may be made to the rear or side of a building if it does the following:

- An addition should maintain the alignment of storefront elements, moldings, cornices and upper-story windows that exist on the main part of the building and its surrounding context.

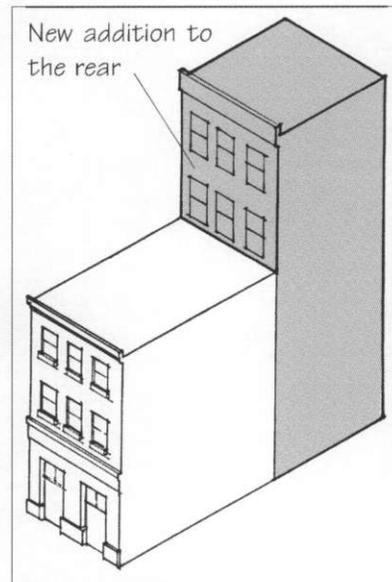
New addition to the rear

Appropriate alternative approaches to additions.

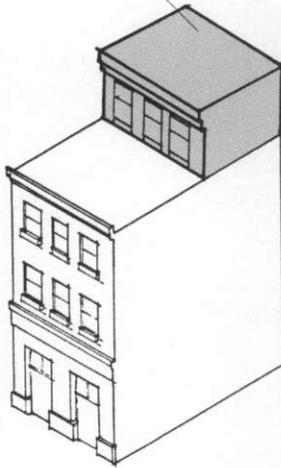
Roof addition set back from the front

9.29 An addition may be made to the roof of a building if it does the following:

- An addition should be set back from the primary, character-defining facade, to preserve the perception of the historic scale of the building.
- Its design should be modest in character, so it will not attract attention from the historic facade.
- The addition should be distinguishable as new, albeit in a subtle way.

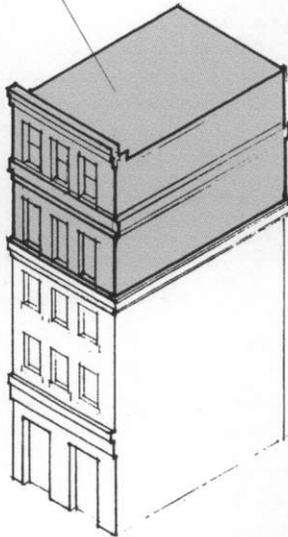
Roof addition in the same plane as the original, but differentiated with details

Appropriate alternative approaches to additions. Not all architectural styles are compatible with this approach.

9.30 In limited circumstances, an addition may be made to the roof of a building and not be set back from character-defining facades, if it does the following:

- An addition should be distinguished from the existing building. A change in material or a decorative band can be considered to accomplish this.
- An addition should maintain the alignment of storefront elements, moldings, cornices and upper-story windows that exist on the main part of the building.
- The addition should also be compatible in scale, texture and materials with the original.

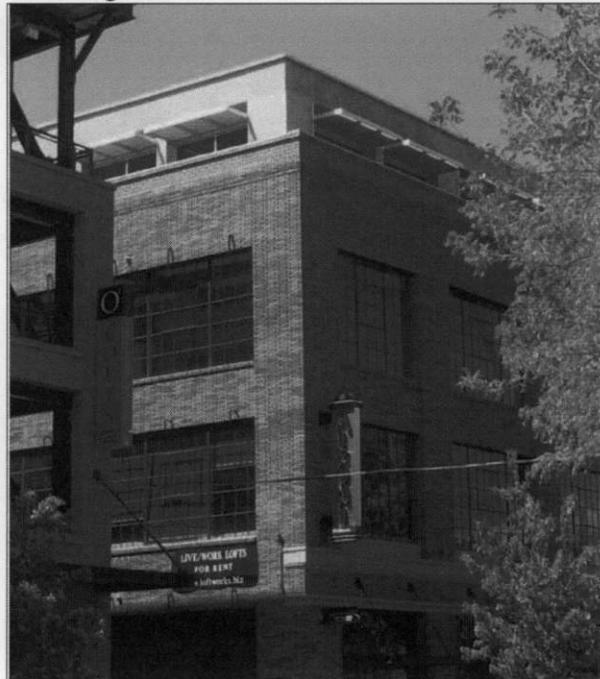
This new rooftop addition to a landmarked structure is modest in character and does not attract attention from the historic structure.

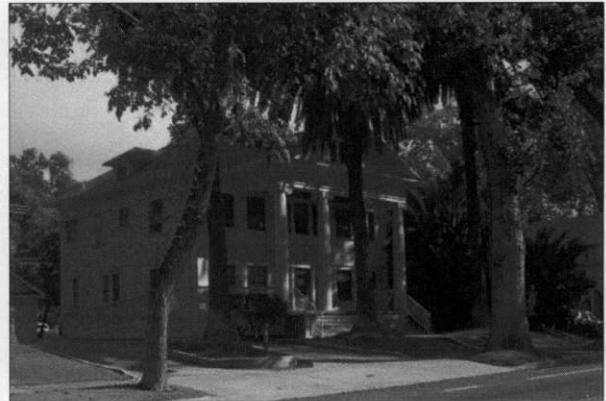
Some relatively large houses exist in the Boulevard Park Historic District, such as this full two-story Neoclassical house. These are typically raised a few feet above grade.

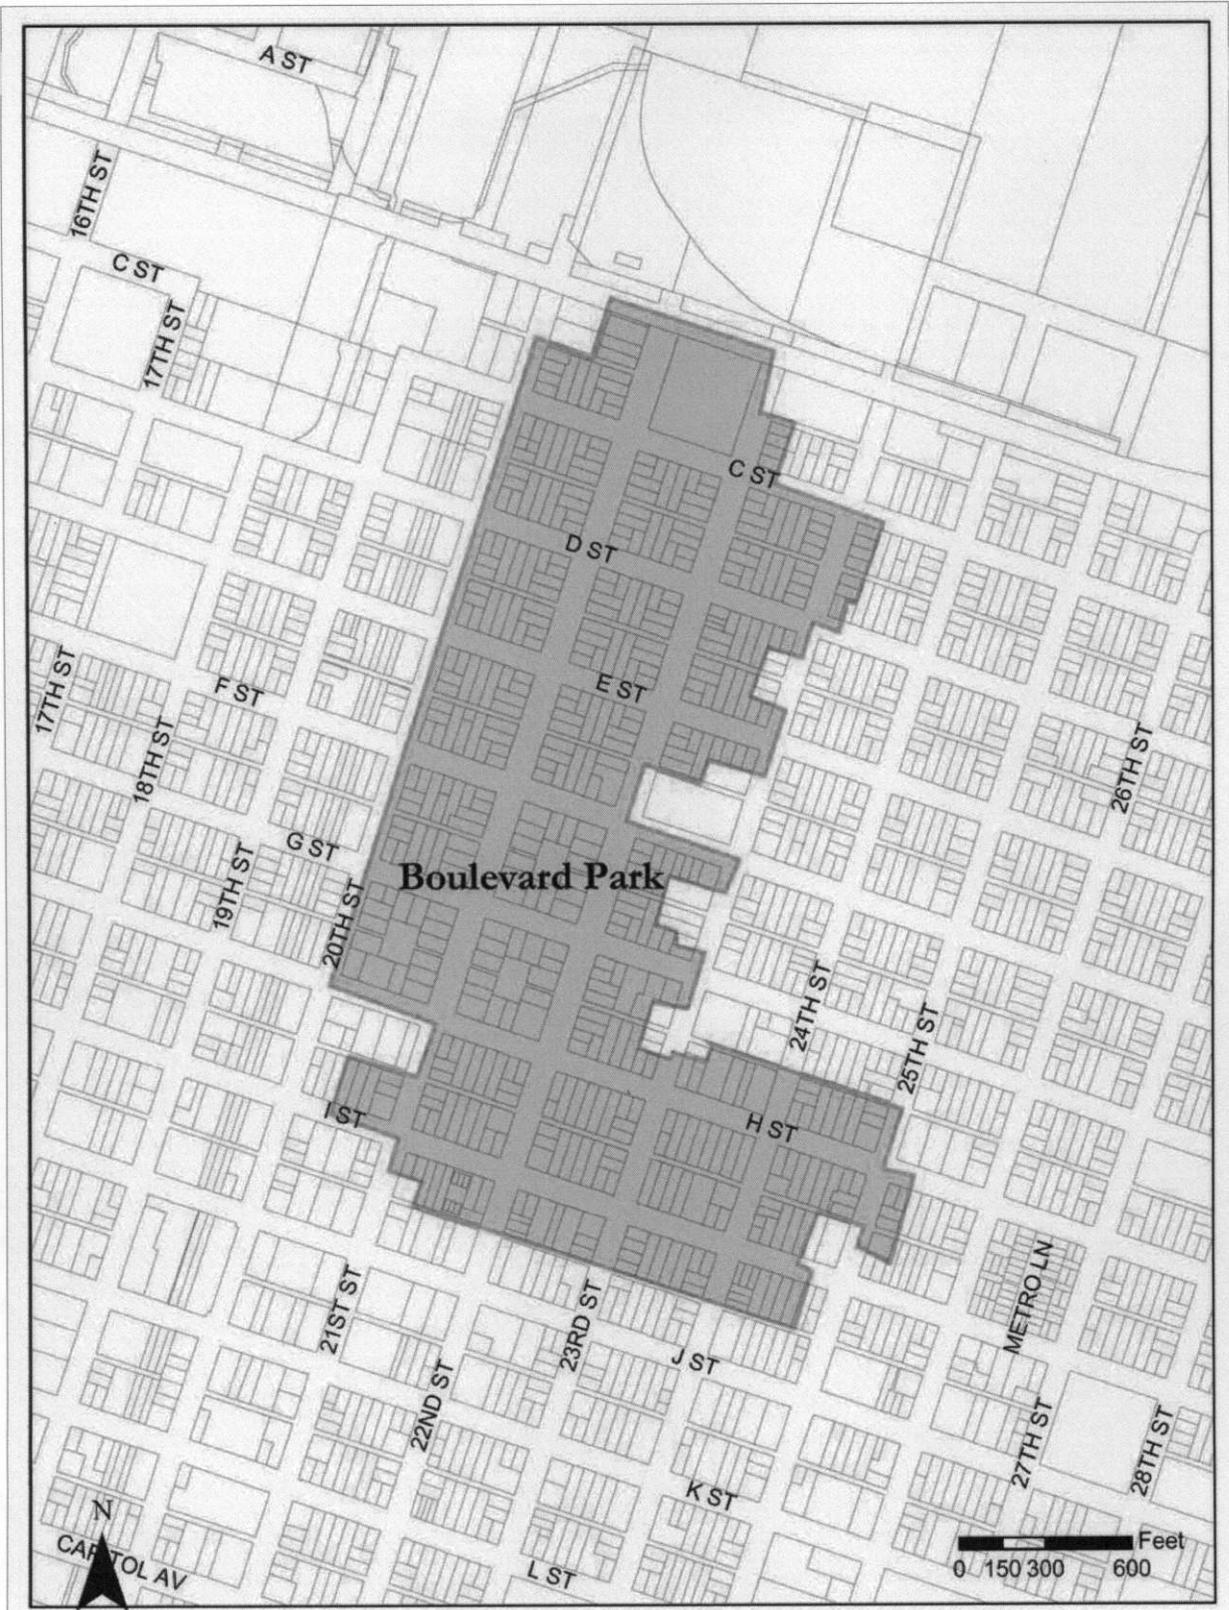
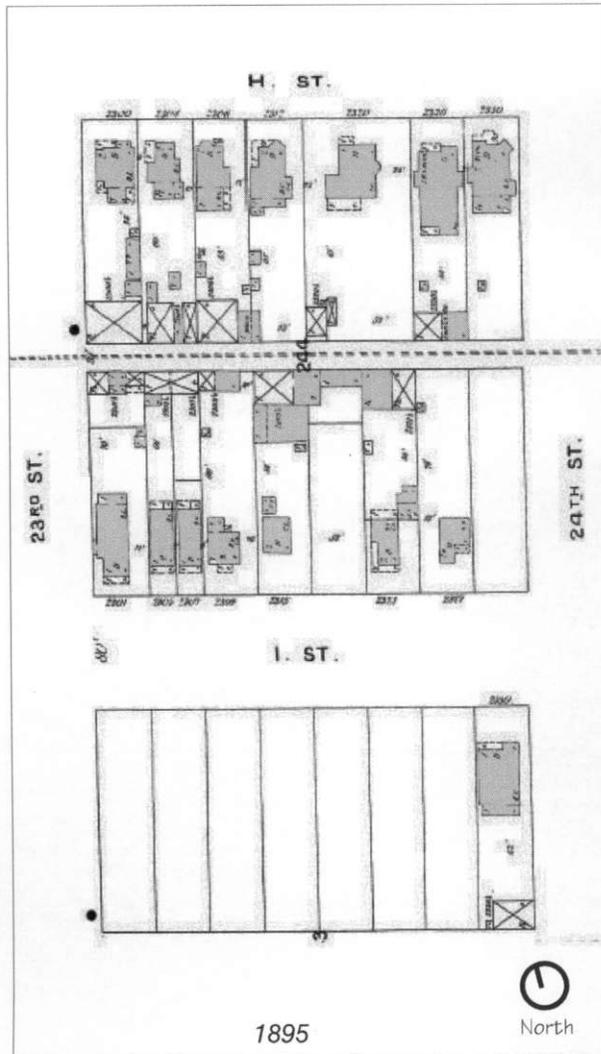
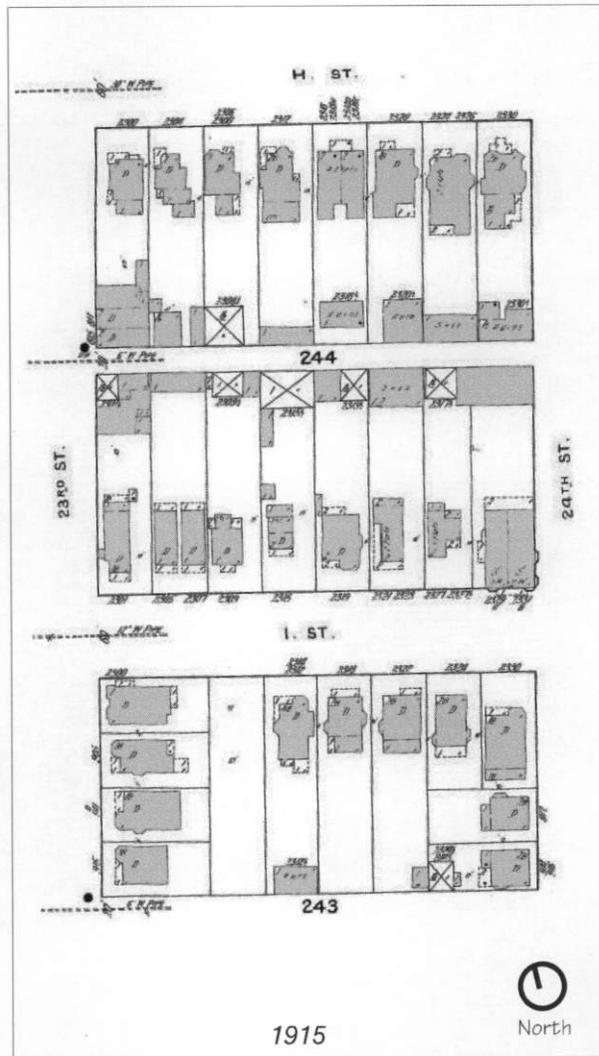
EVOLUTION AND CHANGE IN THE BOULEVARD PARK HISTORIC DISTRICT

A comparison of two historic maps illustrates the basic framework of the Boulevard Park District and also its evolution. In the earlier map from 1895, one block is relatively mature in its development, whereas the other, on the south side of I Street is virtually undeveloped, with only one house being documented. (Note that the heart of this neighborhood at that time was a race track.) In block 244, lots face the lettered streets and secondary structures are served by an alley. The alley structures align uniformly.

Along the H Street face, there are seven lots. Each has one single family house. One lot, the third from the right, is a double-width.

The same set of blocks appears in the upper right image from 1915. The northern block, facing H Street, has increased in density: The larger central lot has been subdivided into two lots and, on one of them an apartment building with four flats has been added.

The original house has been shifted to make room for the apartments and it appears that a small wing has been removed. On the other side of block 244, another single family dwelling has appeared in the middle block and a corner store with apartments above has been constructed on the corner of I and 24th Streets. The block on the bottom, which also faces I Street, has filled in with eleven single family dwellings and one lot remains vacant. In each case, note that the four lots at the top, facing 23rd Street, were carved from two deeper lots that earlier had faced I Street. Throughout the area, building setbacks vary somewhat, but within a relatively narrow range.

This analysis reveals an important fact, that change has occurred in the past within this district. This suggests that, because change is a part of the area's heritage, it should be accommodated today, when it is conceived to be compatible with the historic character.

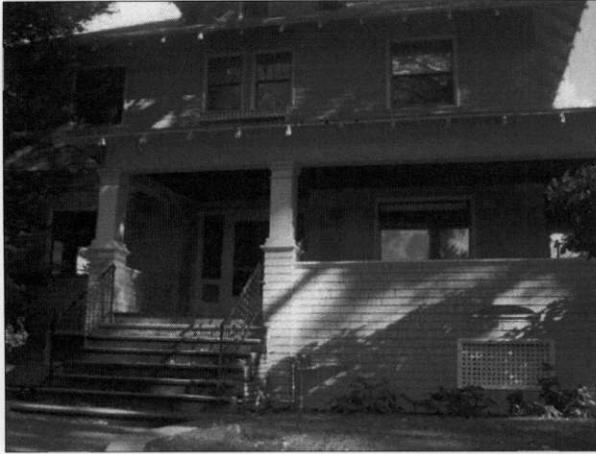
Many buildings in the Boulevard Park Historic District exhibit Craftsman stylistic details.

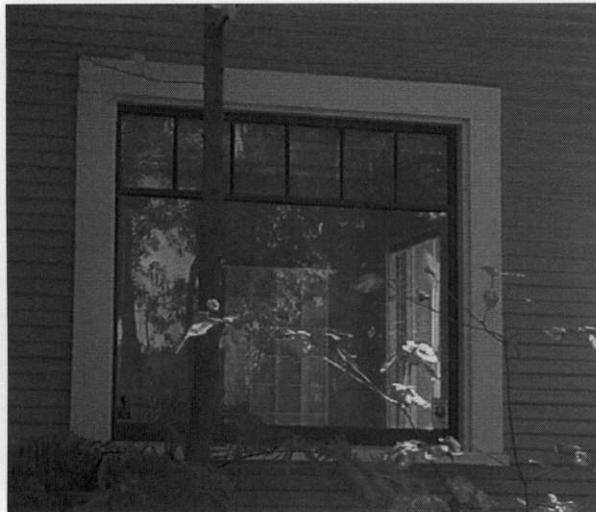
Windows and doors are trimmed with wood members that have substantial depth and project noticeable shadow lines, which help contribute to the sense of scale and visual interest of historic structures in the district.

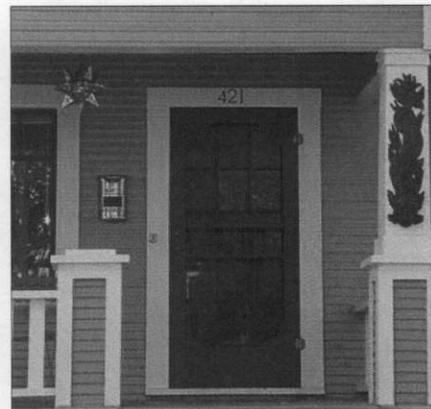
Doors with trim of substantial depth are typical.

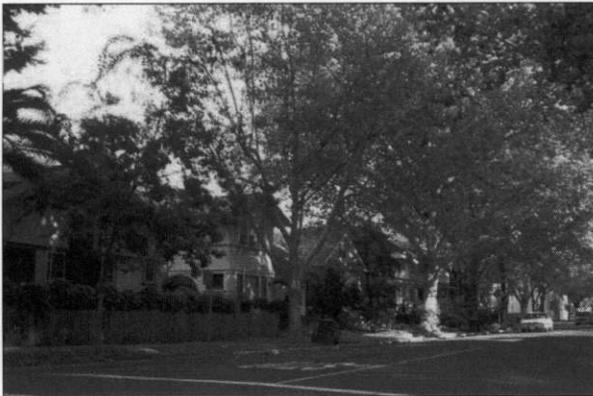
- Dormers and bay windows are prevalent. They visually break up the mass of a building and add visual interest.
- Raised front porches and steps are typical. These reflect the "high water" design techniques used in response to flooding.
- Large decorative windows, with substantial trim and details appear on many buildings.
- Neocolonial bungalows have distinctive front porches and stairwells.
- Victorian era buildings have compact bays, bracketed cornices and turned spindles.
- Craftsman Bungalows have wide overhangs with brackets and exposed rafter tails
- Full glass front doors are used on some structures.

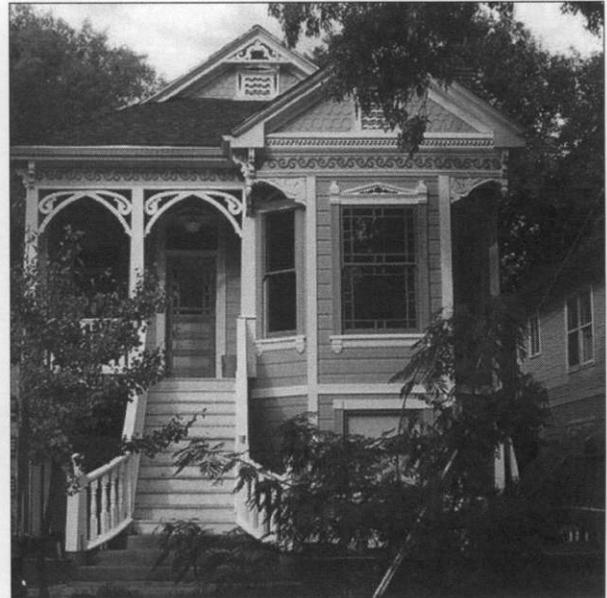
Raised cottages are a part of the character of the Capitol Avenue Historic District.

- Varying setbacks of ten to fifteen feet allow for green space in the front of structures. Further variation occurs between those with stairs extending to the sidewalk and others that are setback further.
- Open space is located to the rear of lots, with garages and utility structures aligned along the alleys.
- Stairs lead to the main floor, which is set over a "flood basement."
- Parcel widths also vary, which results in some variety in building front widths.

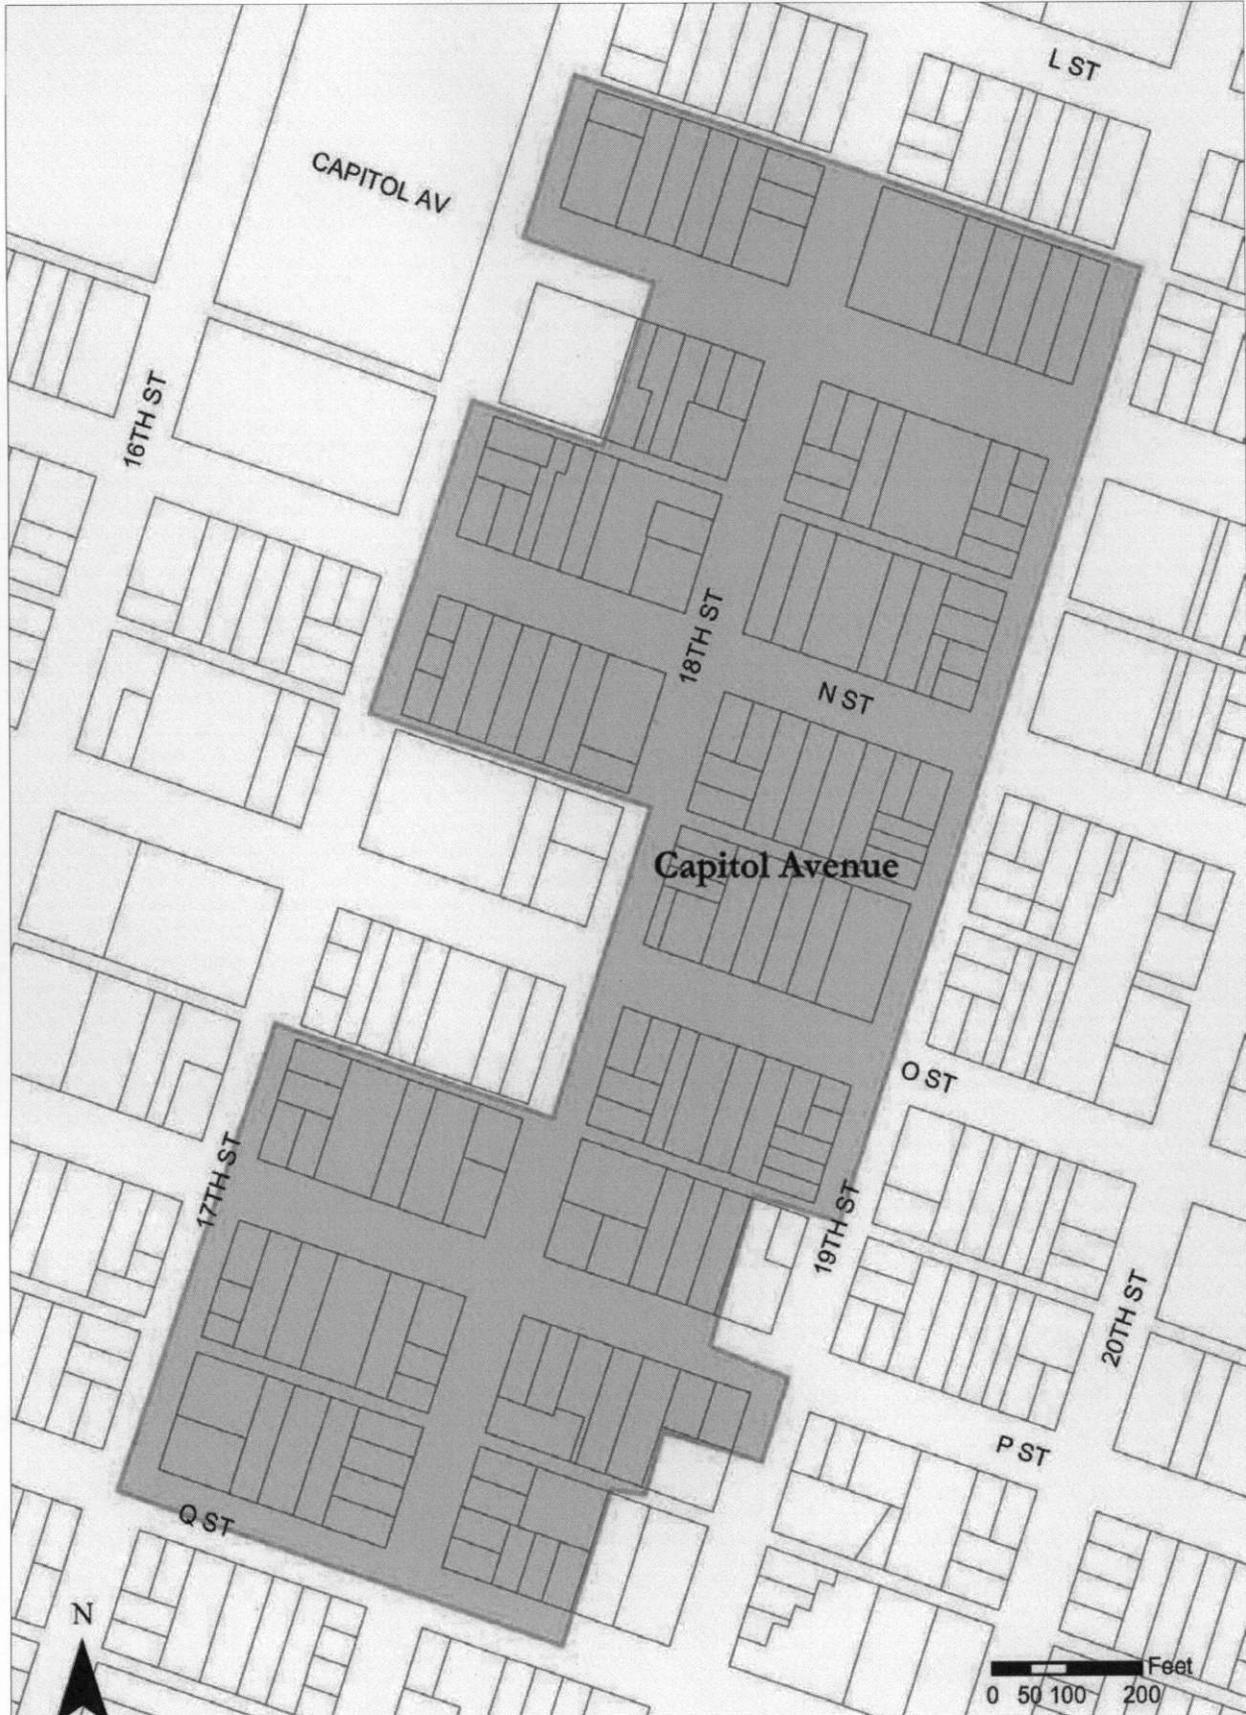
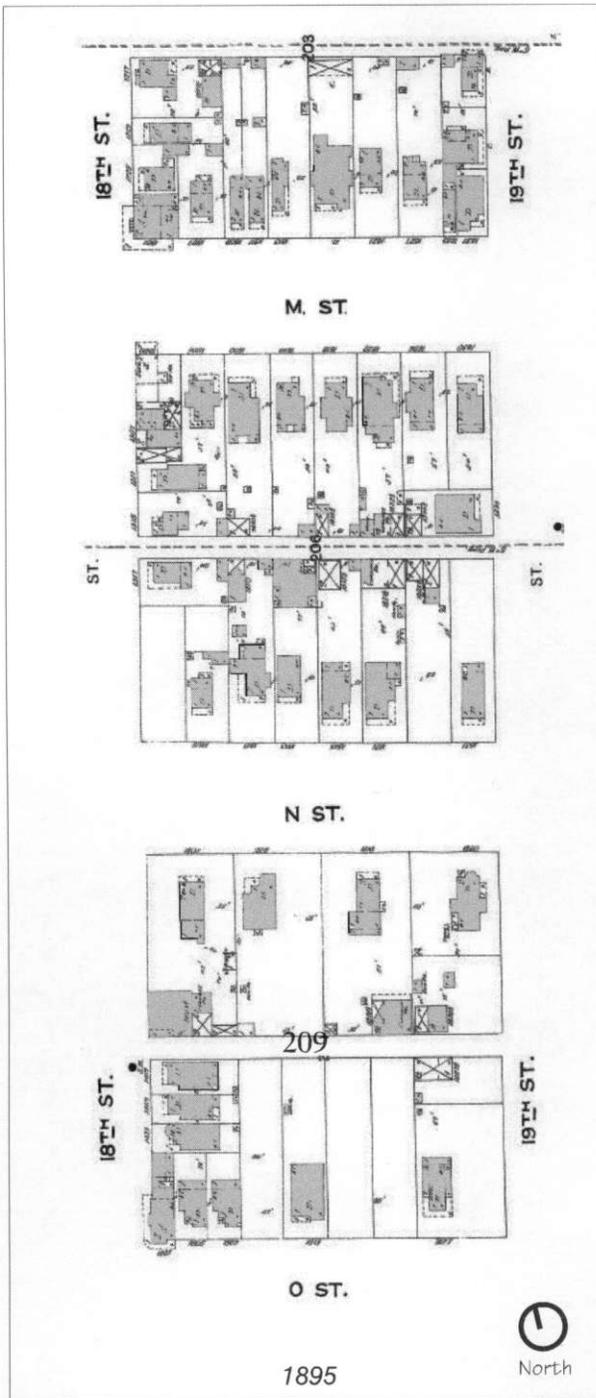
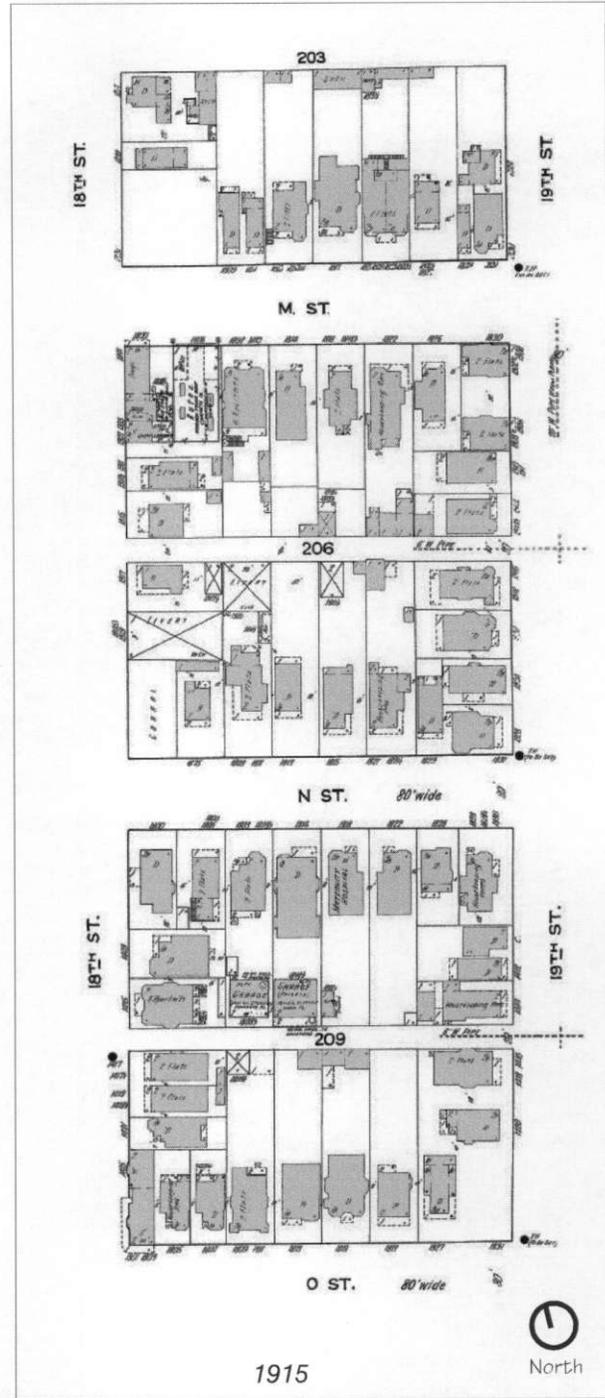
EVOLUTION AND CHANGE IN THE CAPITOL AVENUE HISTORIC DISTRICT

In 1895, maps document emerging development patterns in the Capitol Avenue District. On Capitol Avenue itself (then M Street), single family dwellings are predominant. Setbacks vary on the north side of the street. Farther south (to the left), development is more sparse, especially in block #209. Compare with the same area, upper right image, in 1915. By then, the Capitol Avenue area had increased in density, especially along 18th Street. On Capitol, several

buildings are now shown as apartments, flats and rooming houses. An auto business has appeared at the corner of 18th and M. Block #209 has substantially increased in density, primarily with single family dwellings, but several duplex flats as well. Note that short lots facing the numbered streets have been created. These two maps reflect the evolving nature of the district's history and suggest that other compatible changes are also possible.

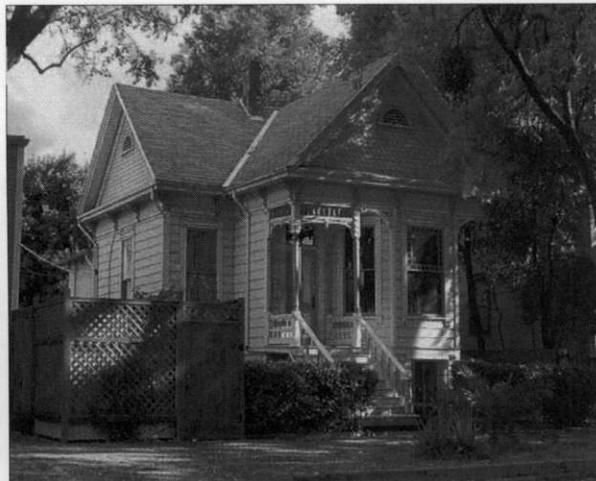
Windows have strong vertical proportions.

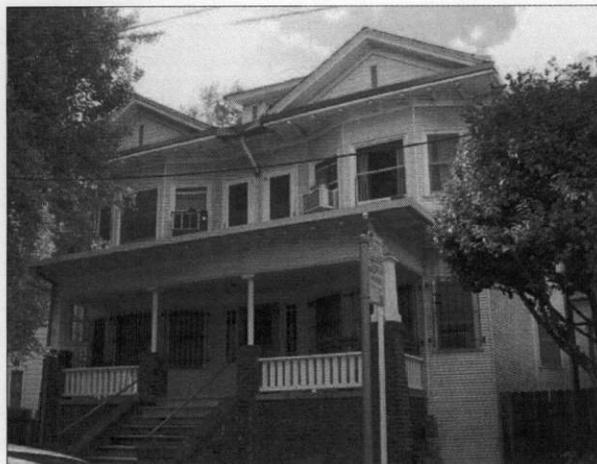
Porches are prominent in the Capitol Avenue Historic District.
