**PROPERTY CONDITION ASSESSMENT
AND CODE COMPLIANCE SURVEY
OF**

**SOUTHWOOD TOWNHOMES
54 QUAY COURT
SACRAMENTO, CALIFORNIA 95831**

ATC PROJECT NO. 53.28995.0001

MARCH 18, 2005

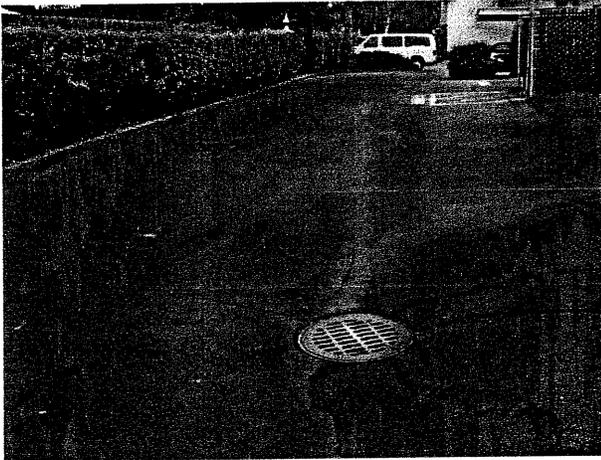
The asphalt pavement and striping appeared to be generally in fair condition with localized medium severity alligator cracking observed throughout the parking areas. Striping was highly faded throughout the Property.

Photo 3: Lateral and alligator cracking and storm water drain

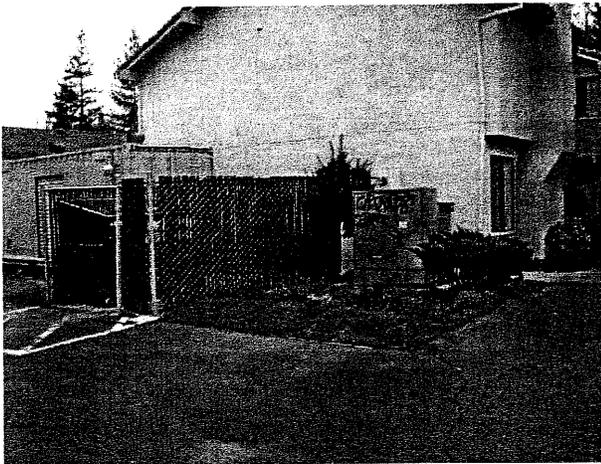
Photo 5: Typical Storage shed, trash receptacle enclosure and pad mounted transformer

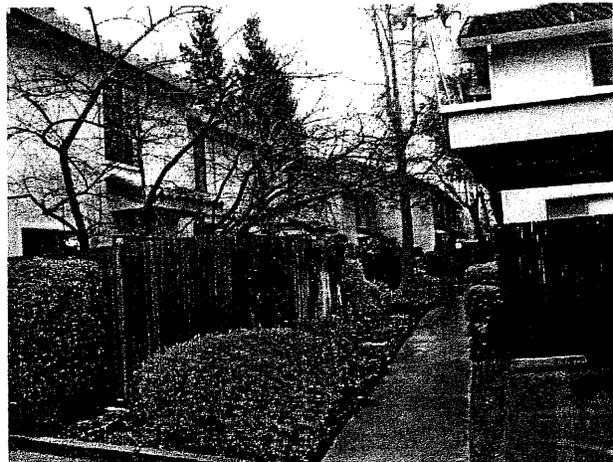
Each tenant unit features a wood slat fence that encloses the patio and is approximately six feet in height. The fencing at each tenant unit was observed to be in fair condition with some sections showing deterioration and in need of replacement. A portion of the fencing used to enclose the patio areas appeared to have been recently replaced.

Photo 6: Wooden fence enclosed patio areas, landscaping and common walkway among buildings

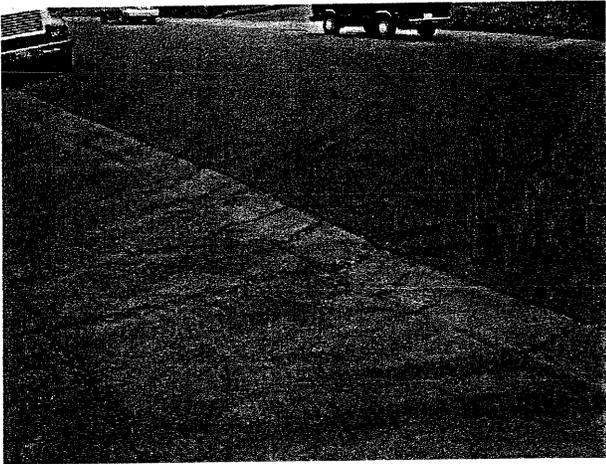
Photo 7: Typical entrance drive deterioration

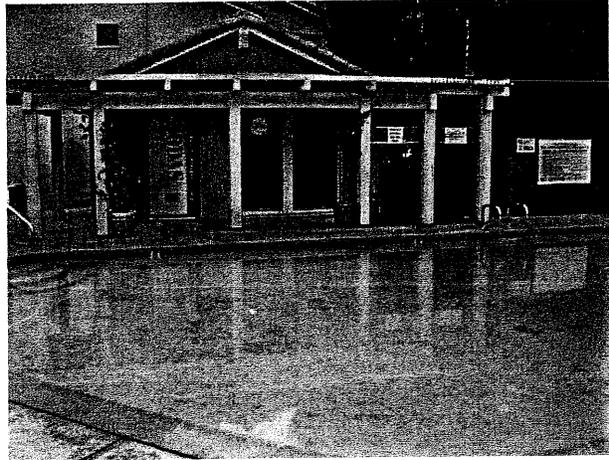
The in-ground concrete swimming pool and adjacent spa feature ceramic tile trim and concrete coping. The swimming pool is located adjacent to the sales office and appeared to be in good condition. The swimming pool deck is constructed of concrete and appeared to be in good to fair condition with areas of localized cracking.

Photo 8: Swimming pool, patio cover and office beyond

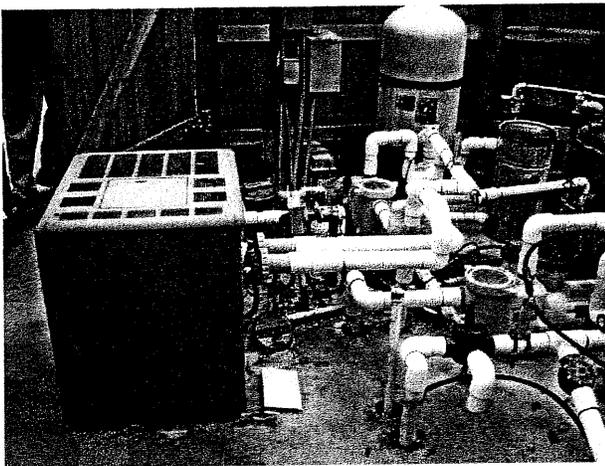
The swimming and spa pool pump, water treatment and filtration equipment appeared to be in good condition and according to Ms. Gordon the heater, filtration and pump equipment for the swimming pool and spa was installed in 2003.

Photo 11: Pool heating and filtration equipment

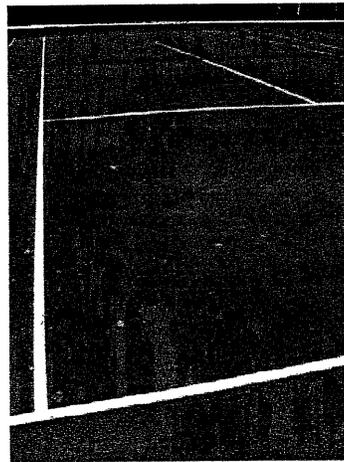
A tennis court featuring a coated concrete surface is situated adjacent to the swimming pool area. The site contact did not know when the tennis concrete pavement was last restriped. The concrete pavement and striping appeared to be generally in fair condition with localized areas of cracking and surface deterioration observed court wide.

Photo 12: Tennis court cracking and surface deterioration

The pavement appeared to be in fair condition and the court markings are clearly visible. In general, concrete pavement can be expected to provide approximately 30 years of useful life and repainting of the court markings should be conducted every five years.

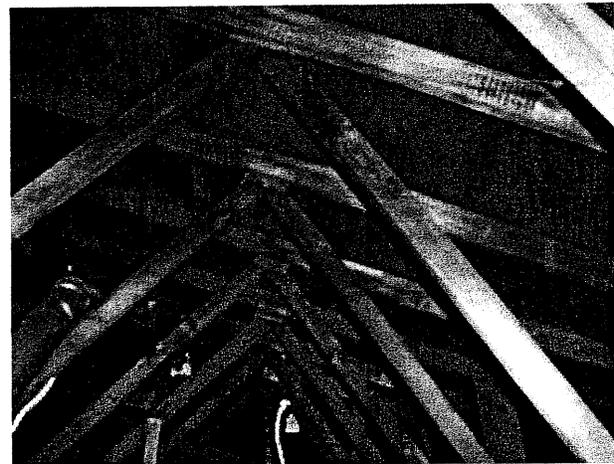
Attics were observed at a representative number of buildings. Crawl space for attic access is provided through a lift-out panel in the ceiling of the master bedroom closet in each tenant unit. The attic is constructed with wood beams, trusses and perkins supporting plywood decking. Gypsum board separates individual tenant space attic areas. The attics observed featured blown-in type insulation covering the gypsum board ceiling areas between beams.

Photo 18: Typical above ceiling roof structure

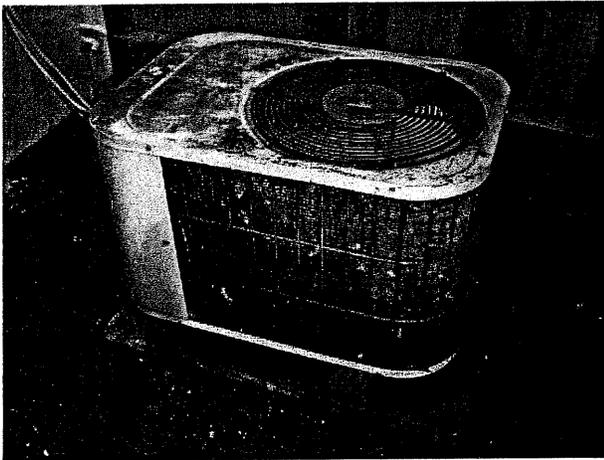
Each dwelling unit is heated and cooled by an electric air-to-air split system heat pump. The fan coil unit is located in a mechanical closet in an interior closet. The air-conditioning condensing unit is pad-mounted on grade and located in the enclosed patio area of each tenant unit. The heat pump equipment observed appeared to be generally in fair condition with advanced weathering visible on the exterior components. There was also tenant reported inefficiencies in the observed systems. In general, heat pump equipment can be expected to provide approximately 20 years of useful life. The heat pump equipment appeared to vary in age and have been replaced on an as-needed basis.

Photo 21: Typical external component of split system heat pump in enclosed patio area

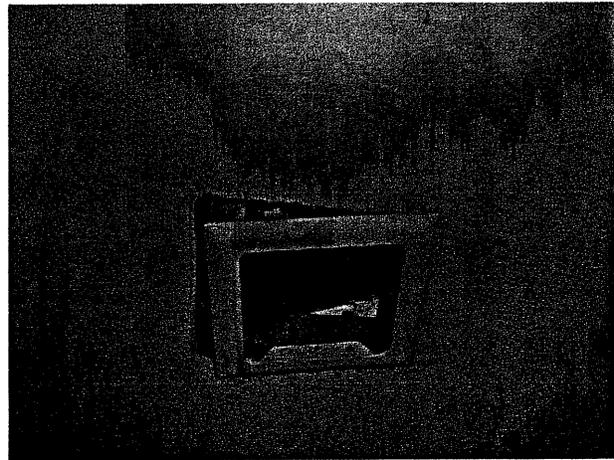
Exterior lighting consists of building- pole- and fence-mounted fixtures that appeared to be in fair condition. Since the survey was conducted during daylight hours, Property lighting levels could not be accurately assessed; however, the lighting layout appears to provide adequate coverage. The fixtures are in fair condition with several fixtures loose from their mountings, missing bulb covers, and broken bulbs.

Photo 22: Typical damaged external light fixture

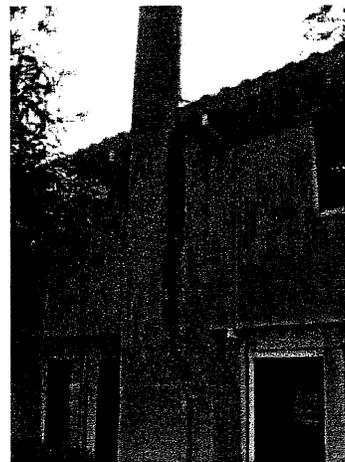
The site contact did not know when the exterior of each building was last painted. In general, exterior painting can be expected to provide approximately eight years of useful life. The exterior paint appeared to be generally in fair condition with peeling, fading and surface deterioration observed on painted wood surfaces at each building. There was also a substantial amount of algae-like staining on the stucco surfaces, apparently from water overflowing from clogged gutters.

Photo 24: Typical green staining caused by clogged gutters

ATC observed debris clogging many of the gutters throughout the Property. These areas should be cleaned during the course of normal maintenance operations.

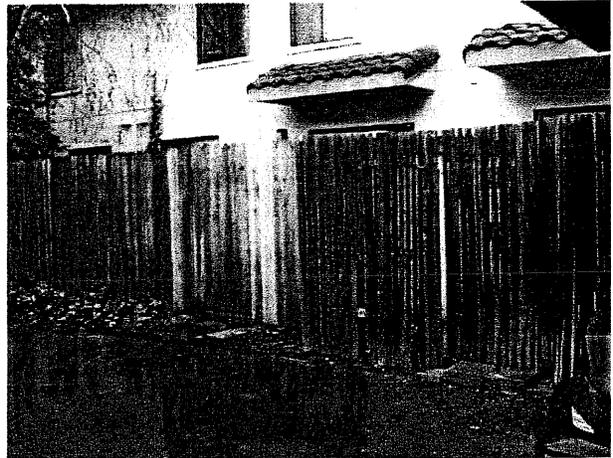
Photo 26: Patio enclosure wood fencing replaced as needed

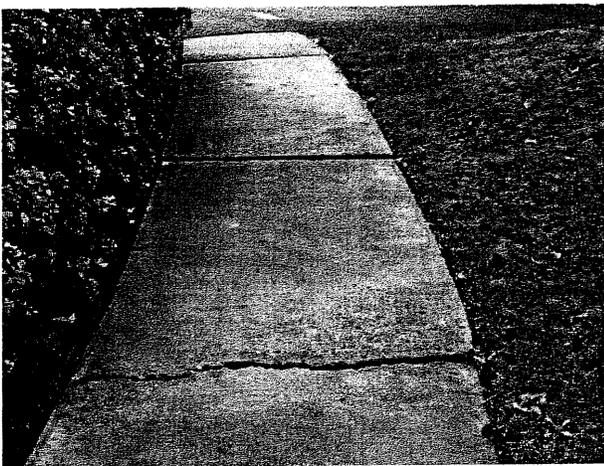
Flatwork such as concrete pedestrian walks provides access to each building. The pedestrian walks appeared to be generally in fair condition with cracking and uneven surfaces caused by mature tree root upheaval. These uneven surfaces present trip hazards.

Photo 29: Cracking and offset caused by tree root upheaval

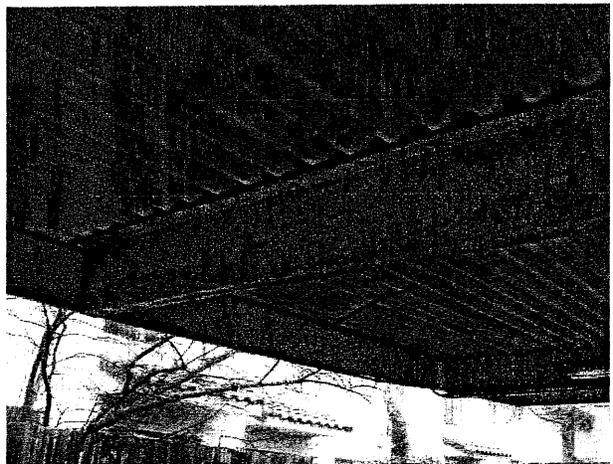
The carports at the Property consist of steel columns and beams and have open sides. They have flat roofs of standing seam metal. The ATC representative observed no improper alignment, cracking or other indications that the carports are in less than good condition.

Photo 30: Car port construction and evidence of needed rust removal and repainting

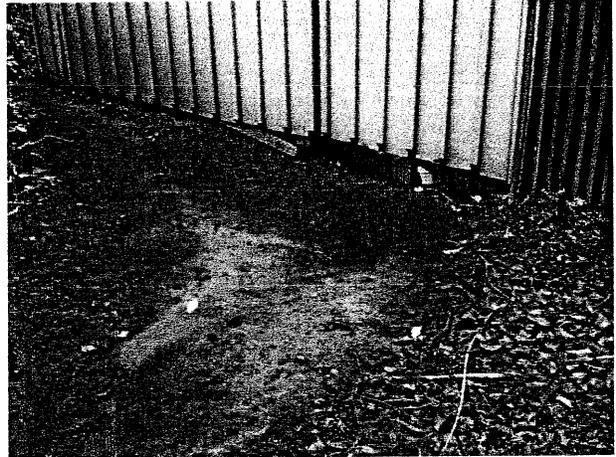
Photo 32: Drainage path of area reported to pond badly behind 33 Quay Court
