REPORT TO COUNCIL

City of Sacramento

Title: Nomination of the Oak Park Downtown Historic District to the Sacramento Register of Historic and Cultural Resources (M07-057)

Map of Nominated Boundaries - Oak Park Downtown Historic District

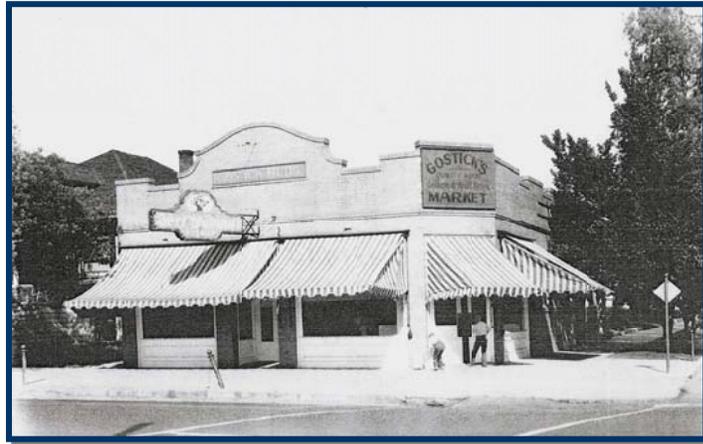
The Gostic Brothers had been in business in Oak Park since 1905. They built this permanent brick building to house their meat market in 1912. Their homes were located immediately to the rear of the market.

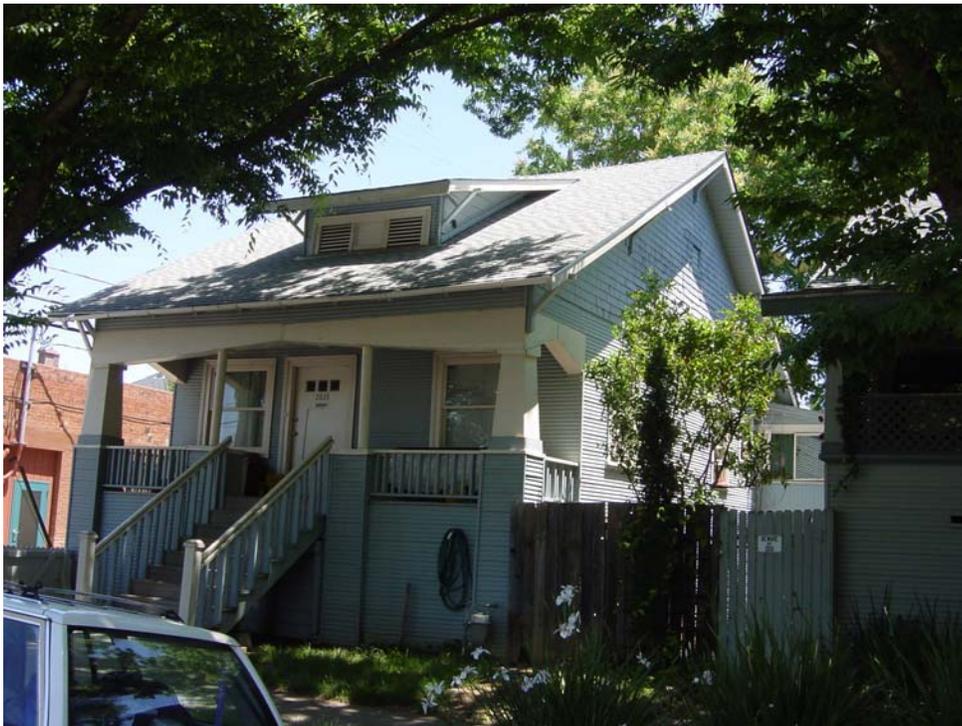
View to the northeast.

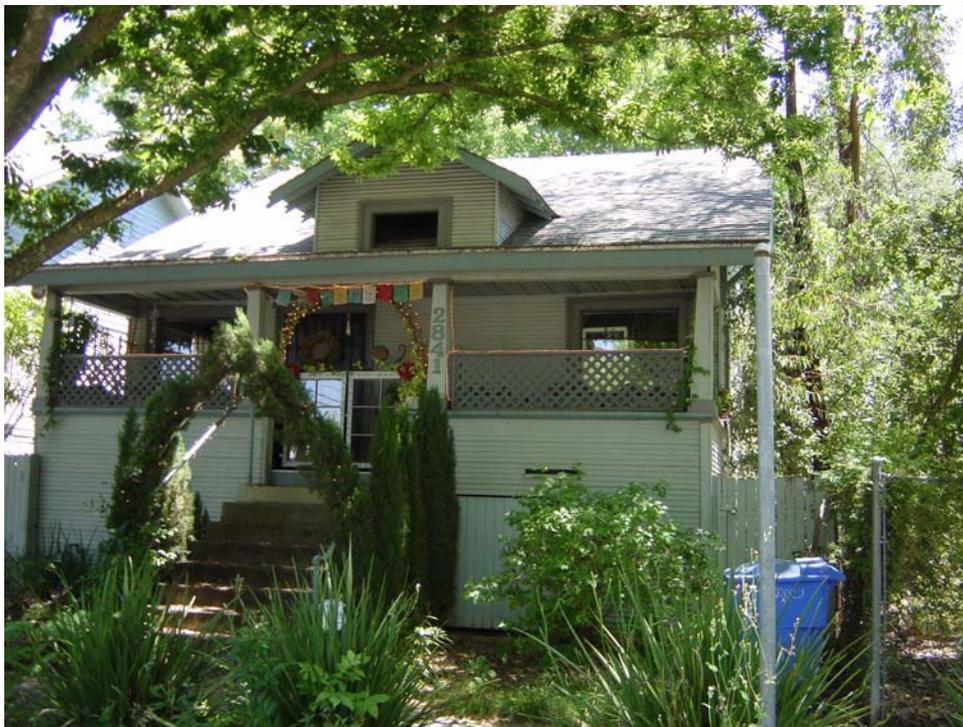
The wood frame house is one story with a raised basement. The side-gabled building stands parallel to the street with a porch that extends across its full width. The gable extends to form the porch roof and is supported by four battered posts. A gabled dormer projects from the composition-clad roof. The building is surfaced with horizontal tiered rustic lap siding, and knee brackets support the eaves at either end of the porch. The house reflects Craftsman design in its form and details such as the battered porch posts.

The wood stairs have been replaced by cement and the stair railings by metal railings. Lattice panels have been placed between porch posts to somewhat enclose the porch.

P5b. Description of Photo: View to the southeast.

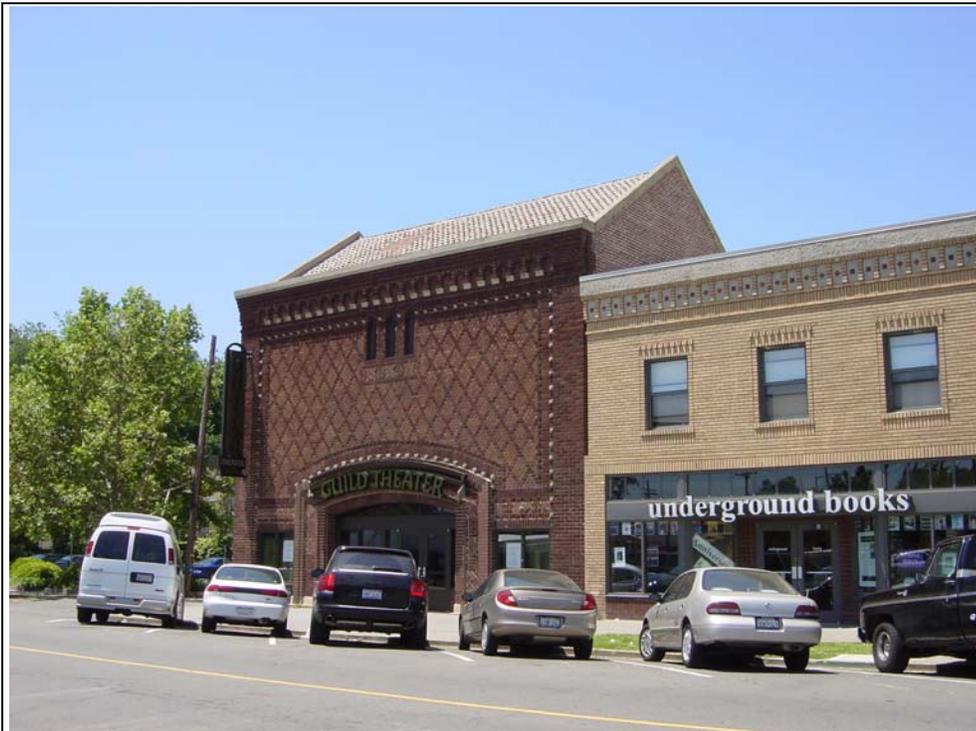
P5b. Description of Photo:
 View to the northwest.
***P6. Date Constructed/Age and Source:** Historic Prehistoric Both
 1915
***P7. Owner and Address:**
 Saint Hope Development Corp.
 P.O. Box 5447
 Sacramento, CA 95817
***P8. Recorded by:**
 Paula Boghosian
 Historic Environment Cons.
 5420 Home Court
 Carmichael, CA 95608
***P9. Date Recorded:**
 December 2004
***P10. Survey Type:**
 Intensive
P11. Report Citation*:
 Oak Park Survey, Sacramento Survey III, 1981, Historic Environment Consultants.

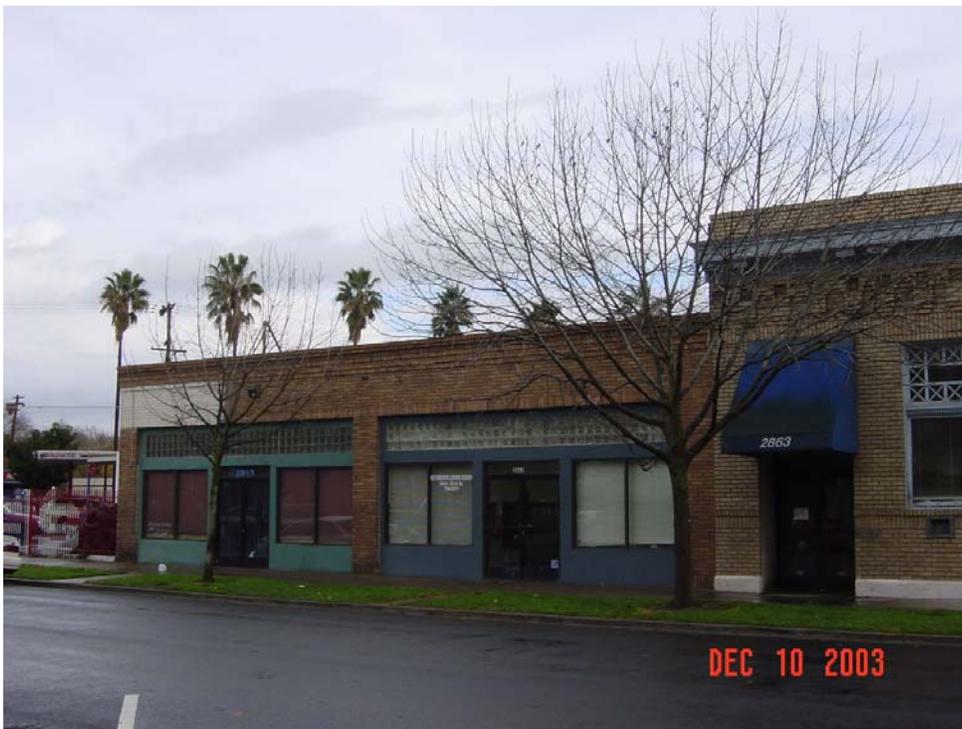
The original store front windows flanking the entrance have been replaced with modern plate glass.

View to the southeast.

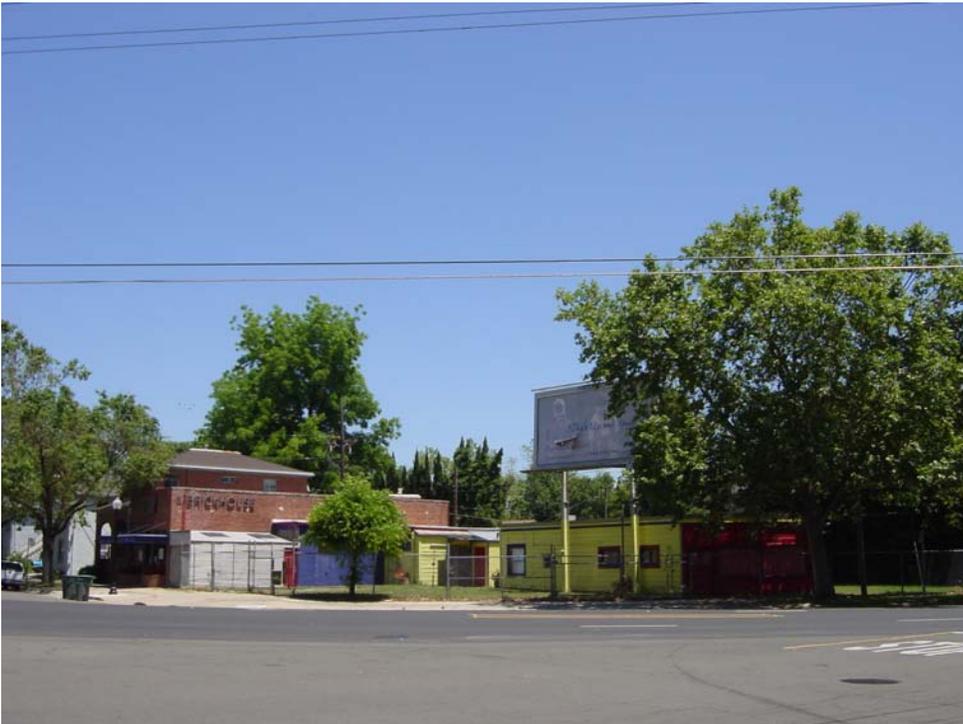
View to the north.

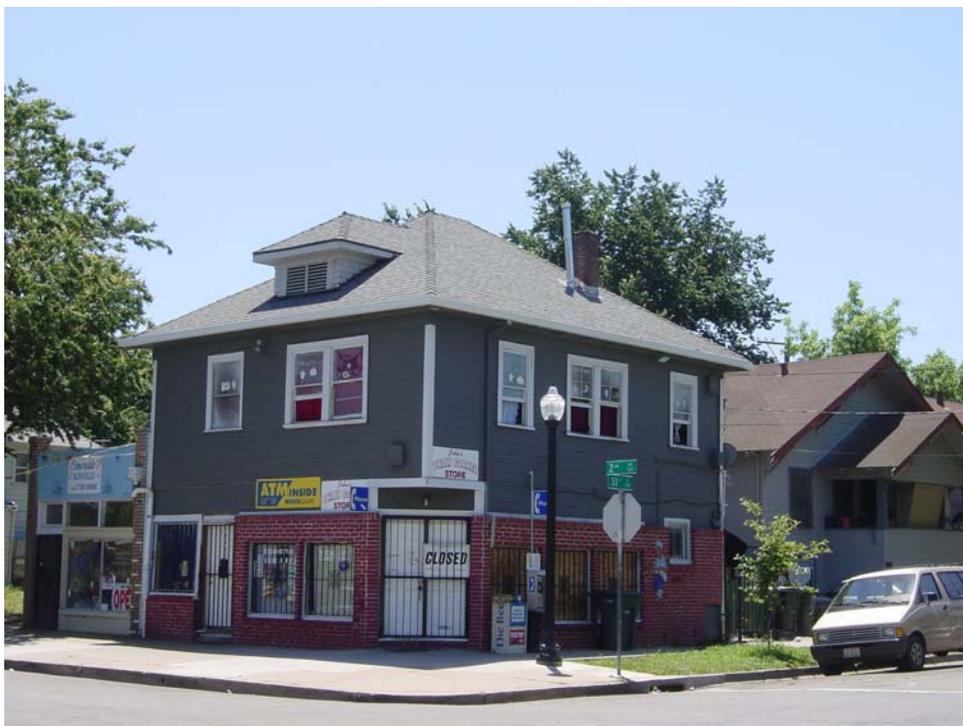
The two story wood frame building stands on the southeast corner of 2nd Avenue and 33rd Street. The building has a hip roof and is almost cubic in form. A hipped dormer projects from the north roof elevation and contains louvered vents. The second floor of the building is sheathed in wood, with three tiered rustic lap siding. The ground floor is surfaced with brick, and a brick chimney projects from the roof. There is a shallow eave overhang with brackets. Second floor windows are double hung, one light over one and four lights over one.

View to the southeast.

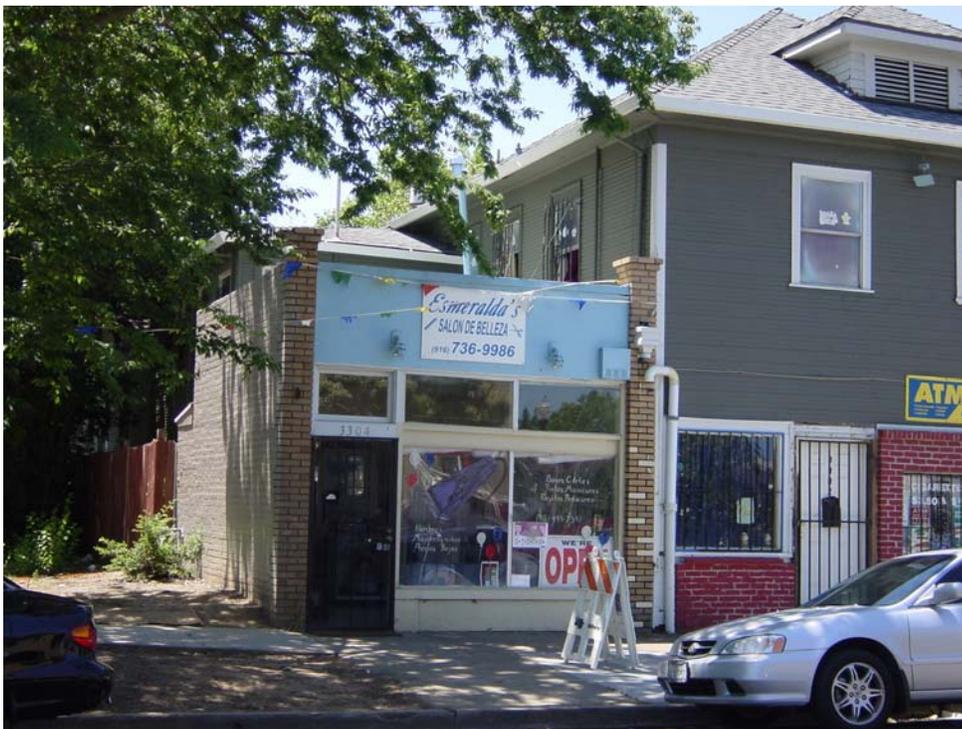
The door may have originally contained glass or glass panels. The space above the show windows may have been slightly modified to accommodate changes in the businesses that occupied the building. Metal protective grilles have been added to the show windows and door. A few of the tan bricks have been replaced on the west side of the façade.

View to southwest

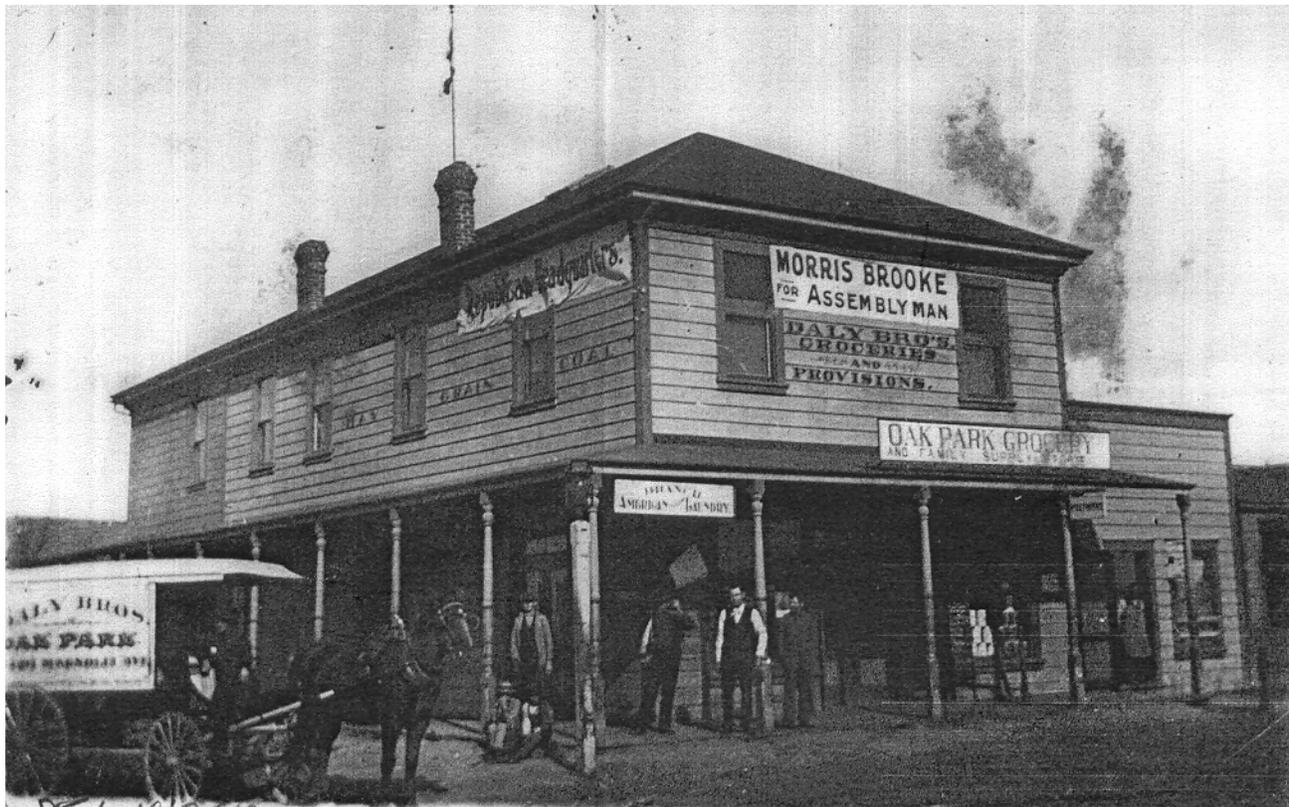
The Daly Brothers Oak Park Grocery, ca 1901. Notice that even the small single-story unit on the right (east) is still in place at the present time.

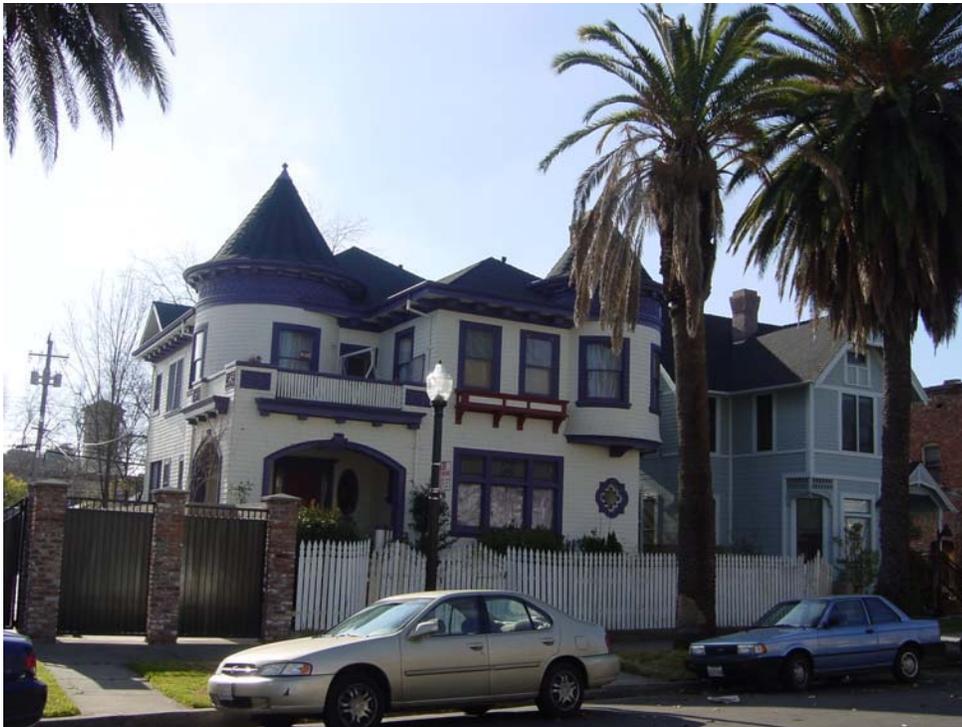
The house is composed of round and rectangular forms, with conical and hipped roofs. Two round Queen Anne towers flank the front of the building, one on the second floor west and a two-story one on the east. The northeast corner entrance contains two segmental arched openings surmounted by a balconied second floor deck. Aside from the Queen Anne tower friezes, stained glass panels and applied bas relief Balcony panels, the ornamentation is rather classical in derivation, with heavy eave and porch projection brackets, centered arch ornaments and oval widow next to the door, with its sidelights. A stained glass trefoil windows lies beneath the projecting second floor tower. The surface is shingled, and windows are double hung, except for the fixed, stained glassed-topped trio of the façade. Moldings are surfaced with a bas relief floral and circle pattern. Entry steps are marble.

Up to this point in its history, the building appears essentially unaltered. However, it was badly damaged during a fire in 2004 and was boarded up. It was rehabilitated with a high level of integrity.

Up to this point in its history, the building appears essentially unaltered. However, it was badly damaged during a fire in 2004 was boarded up. It has since been restored with a high degree of integrity.

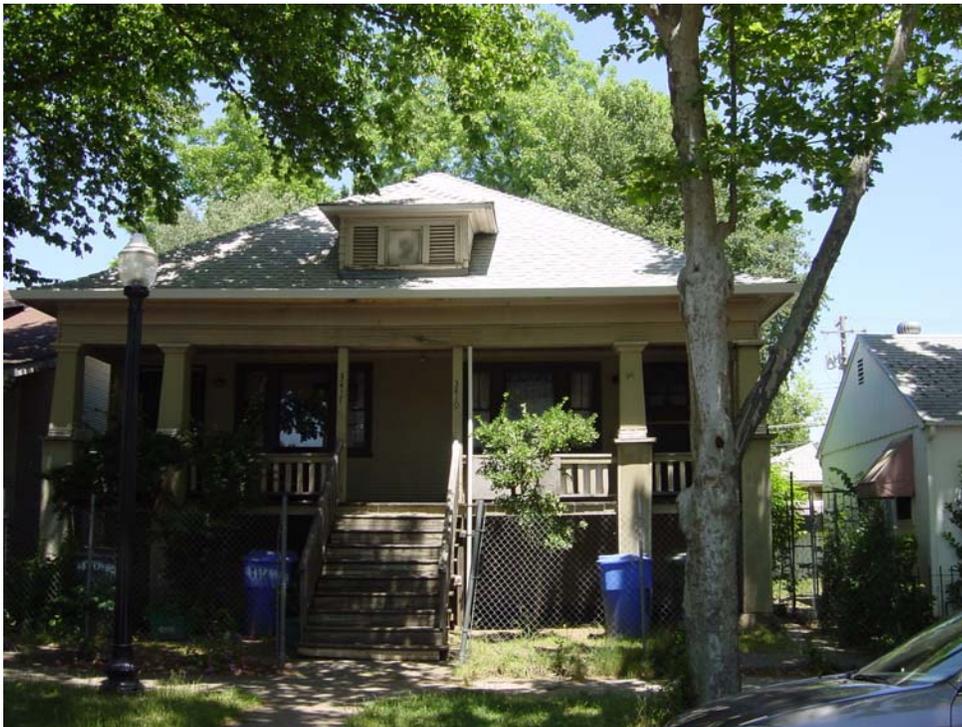
P5b. Description of Photo:
View to the north.

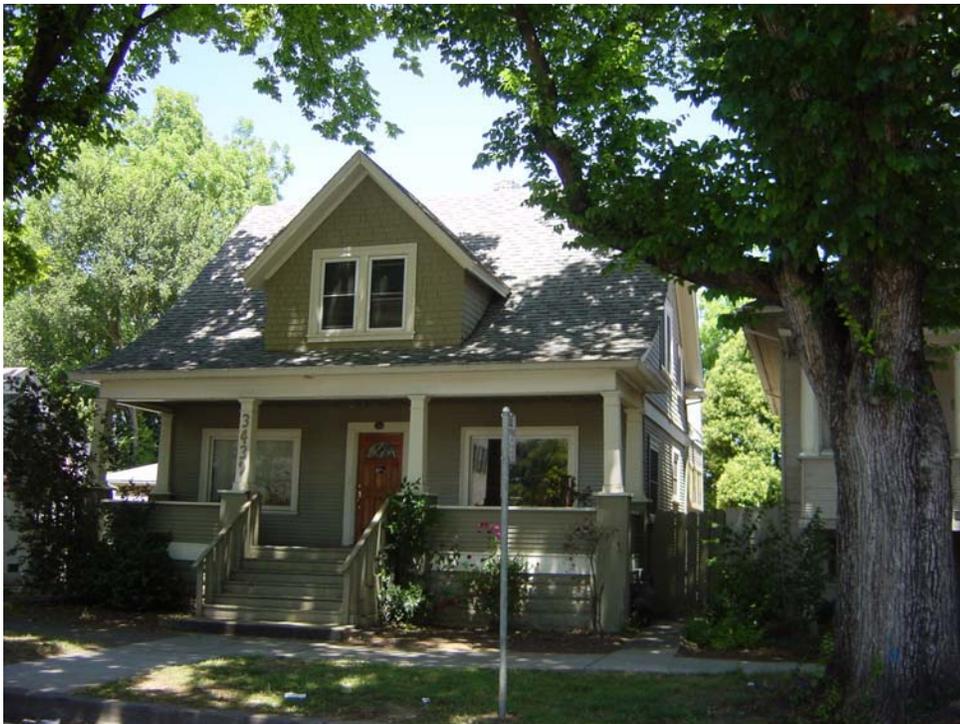
The wood frame residence is one story with a raised basement. The roof is gabled parallel to the street with a large gabled dormer projecting toward the street. The dormer contains a pair of rectangular one light over one, wood-sash windows, framed with simple molding. Window openings on the main floor are also enframed with similar molding. The porch roof is an extension of the side-gabled roof and is supported by squared posts with square capitals. The building is surfaced with rustic tiered horizontal lap siding. The base of the building is of rusticated concrete block, designed to appear as stone courses. Balustrades are angled slats, in a pattern of narrow and wide. Stylistically, the building employs Colonial Revival and Craftsman design influences.

Alterations include a one story addition on the west elevation with an additional side entrance, 3435 4th Avenue. A rear deck at the second floor is not original. Windows are double hung but replaced with metal sash.

View to the north.

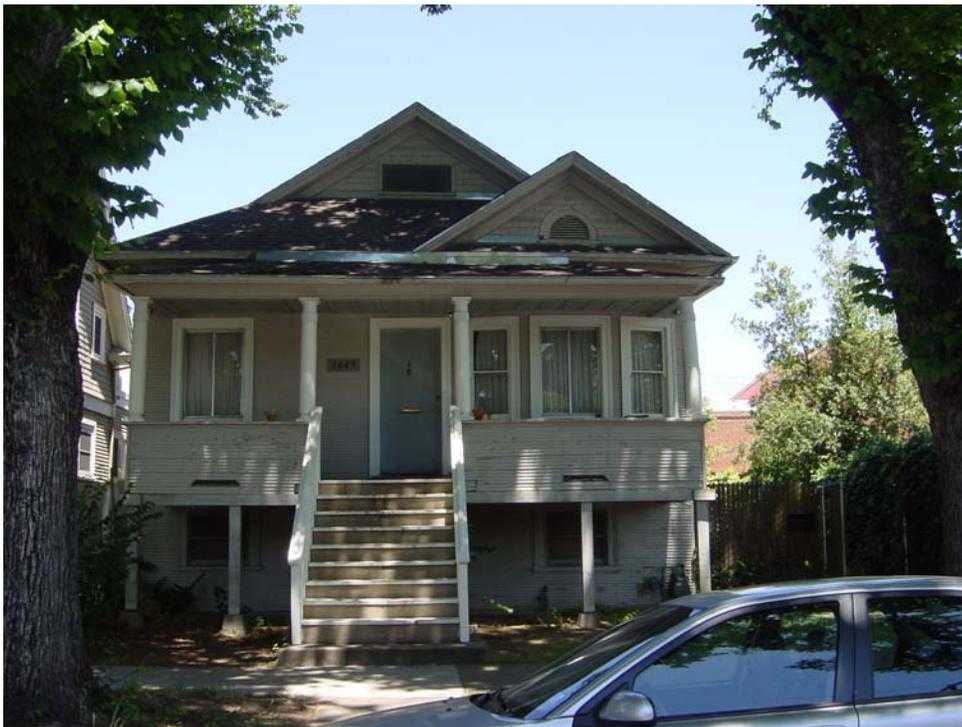
Windows are mixed in style, with some one light over one and some sliding glass in aluminum frames. Simple molding enframes the openings. The residence is sheathed with horizontal 4 tiered panels of rustic wood siding. The porch is supported by posts and there are windows on the lower level.

View to the north.

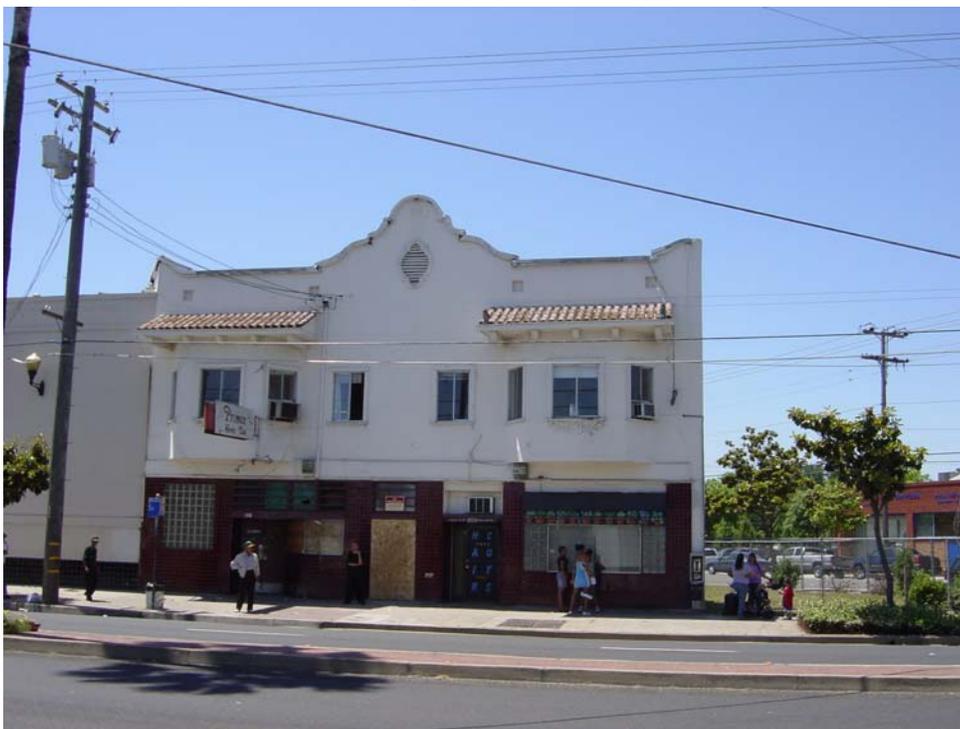
The moderne motif of the ground floor design is competent and originally well composed. Later alterations have damaged its effect.

View to the southeast

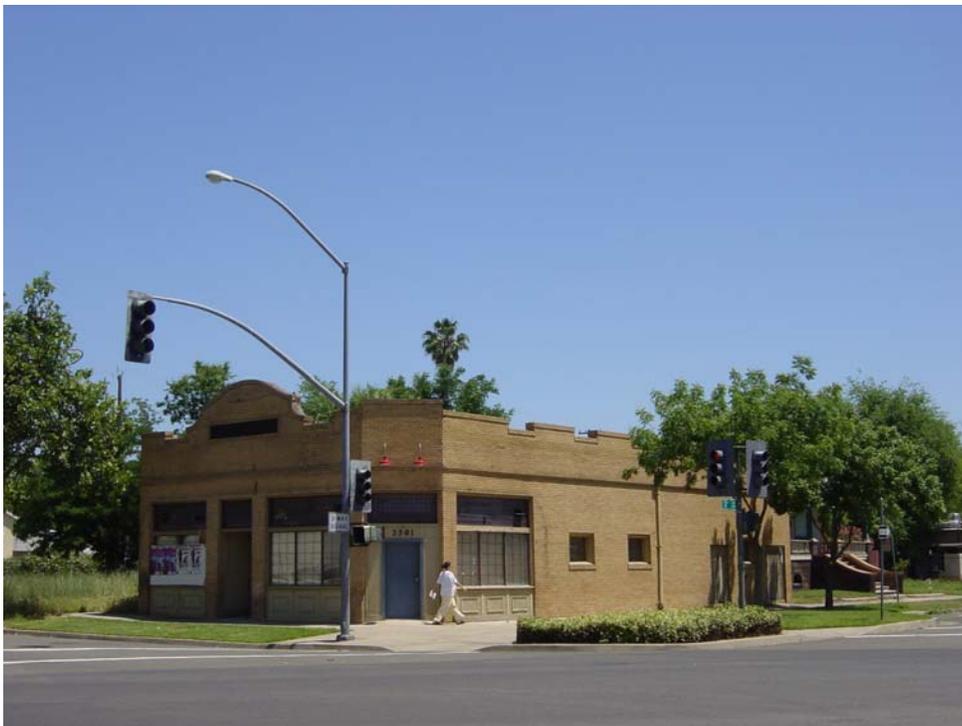
Alterations include the installation of modified show windows, wooden panels with decorative moldings, the replacement of the corner door and addition of wood side panels, and modified side entries.

View to the northwest.

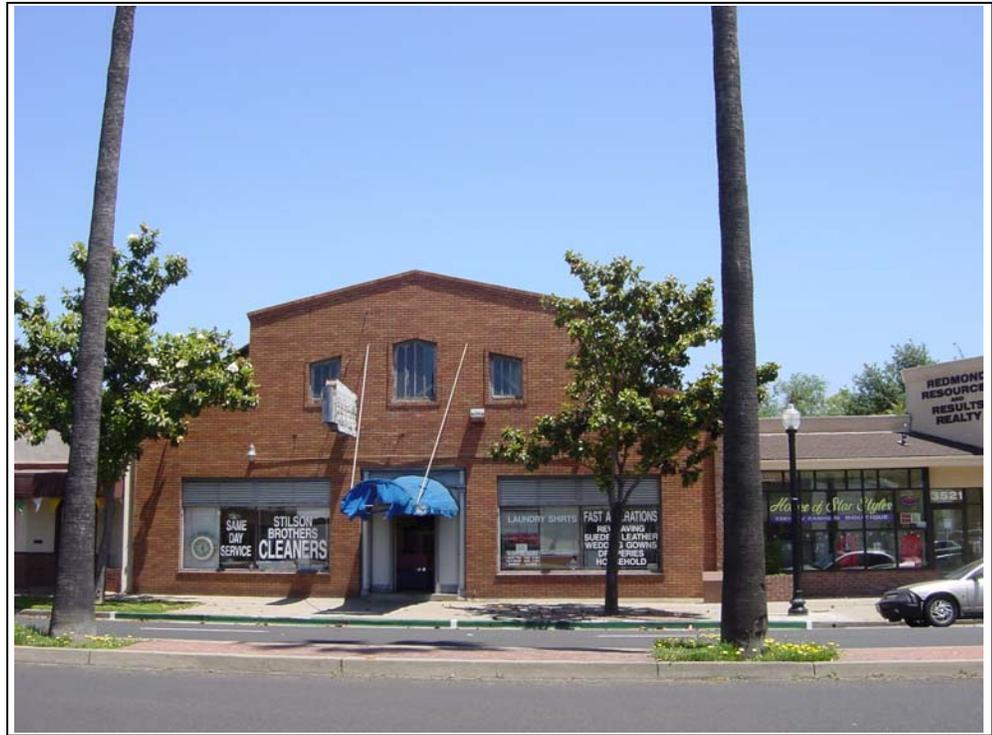
The brick commercial building contains a stepped two story-tall gabled center portion, flanked by shorter slant-roofed sections on either side. This central section contains three fixed wood sash windows at the second floor level. The center one lies directly beneath the gable peak of the building and imitates its gable form. The tops of each of the other two windows follow the slant of the roof above their side. A shallow strip of corbelled brick trims the cornice. The ground floor contains two large fixed show windows, mounted in wood and metal sash, that flank the entrance. Sections of wood louvers project above the upper portions of the windows. The entry door is centered between two covered side lights and two columns, with a section above the door that appears to have held a transom window. An awning extends above the door, supported by guy wires attached to the building above. The entry columns suggest minor Colonial Revival influences. There is a separate building associated with the cleaners on 3rd Avenue at the rear, with corrugated metal and brick, openings with metal sash, and a concrete block east wall.

P5b. Description of Photo:
 View to the northeast.
***P6. Date Constructed/Age and Source:** Historic Prehistoric Both
 1927
***P7. Owner and Address:**
 Ho Suk Cho & Sabrina
 3519 Broadway
 Sacramento, CA 95817
***P8. Recorded by:**
 Paula Boghosian, Historic Environment Consultants
 5420 Home Court
 Carmichael, CA 95608
***P9. Date Recorded:**
 December 2004
***P10. Survey Type:**
 Intensive
P11. Report Citation*: Oak Park Survey, Historic Environment Consultants, 2004, Sacramento Survey III, 1984-85, Historic Environment Consultants
