REPORT TO COUNCIL

Title: Nomination of the Oak Park Historic District to the Sacramento Register of Historic and Cultural Resources (M07-057)

Location/Council District: Oak Park, Council District 5

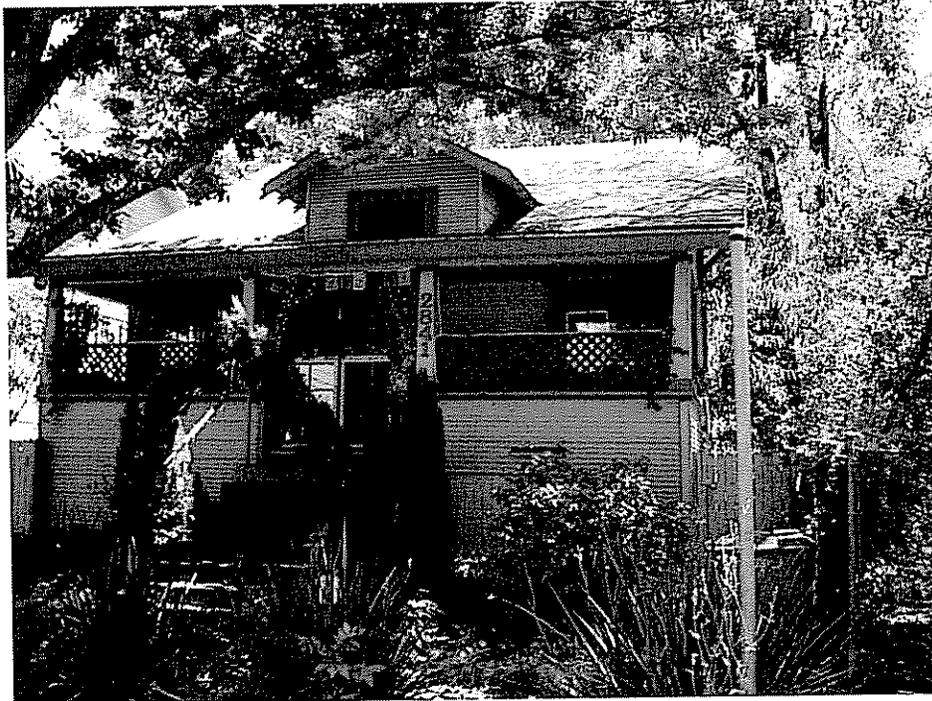
The wood frame house is one story with a raised basement. The side-gabled building stands parallel to the street with a porch that extends across its full width. The gable extends to form the porch roof and is supported by four battered posts. A gabled dormer projects from the composition-clad roof. The building is surfaced with horizontal tiered rustic lap siding, and knee brackets support the eaves at either end of the porch. The house reflects Craftsman design in its form and details such as the battered porch posts.

The wood stairs have been replaced by cement and the stair railings by metal railings. Lattice panels have been placed between porch posts to somewhat enclose the porch.

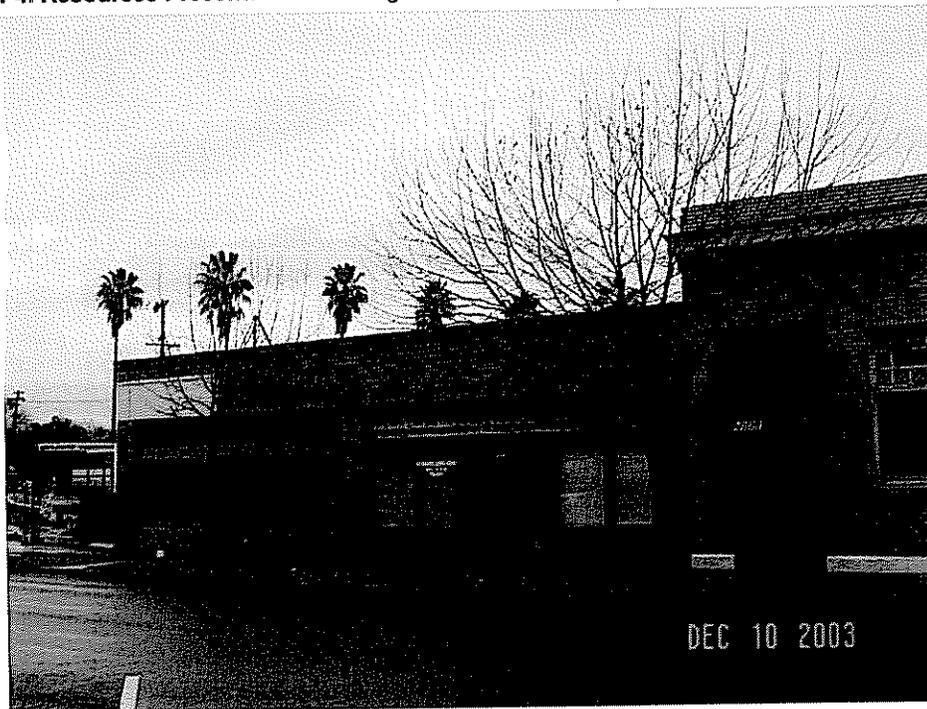
The original store front windows flanking the entrance have been replaced with modern plate glass.

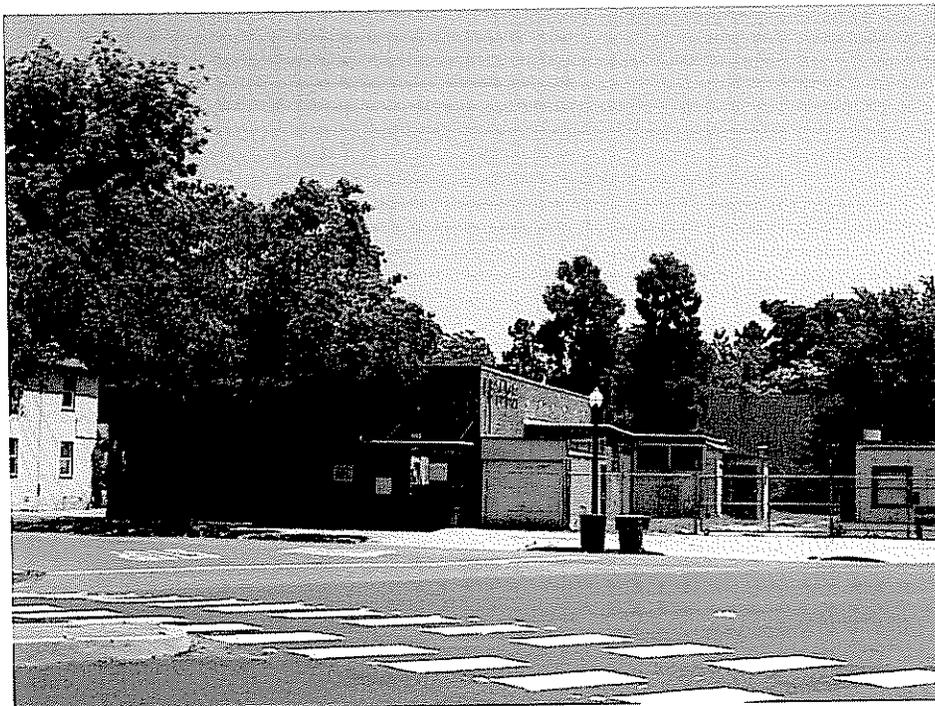
View to the east

The two story wood frame building stands on the southeast corner of 2nd Avenue and 33rd Street. The building has a hip roof and is almost cubic in form. A hipped dormer projects from the north roof elevation and contains louvered vents. The second floor of the building is sheathed in wood, with three tiered rustic lap siding. The ground floor is surfaced with brick, and a brick chimney projects from the roof. There is a shallow eave overhang with brackets. Second floor windows are double hung, one light over one and four lights over one. The ground floor contains three show windows on 33rd Street and three on 2nd Street with a door between. The entry door is placed diagonally on the corner of the building. There is an additional small square window on 33rd Street.

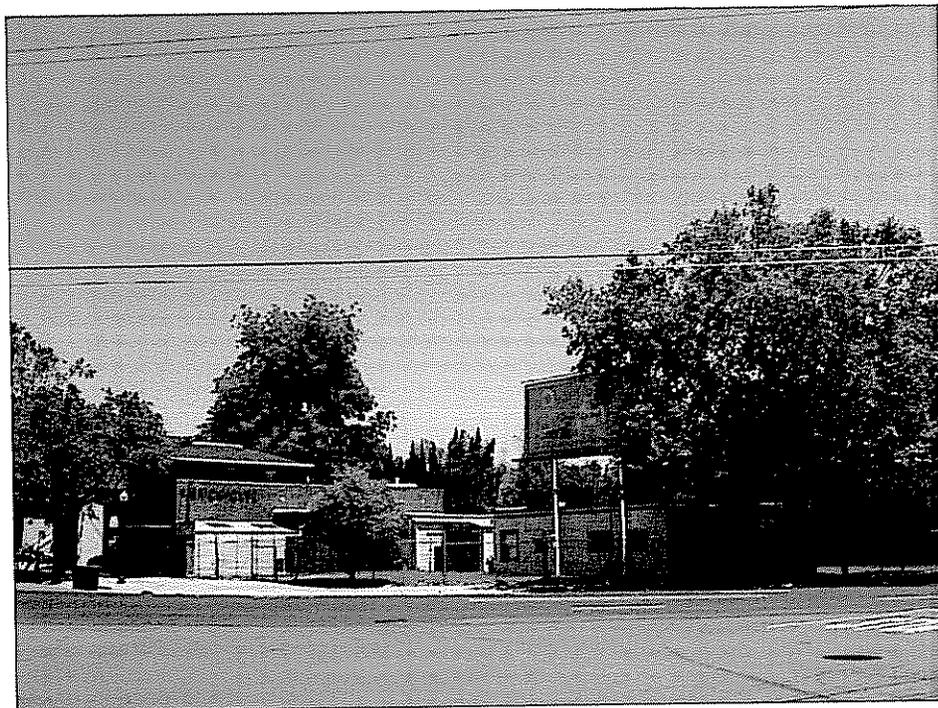
View to the north

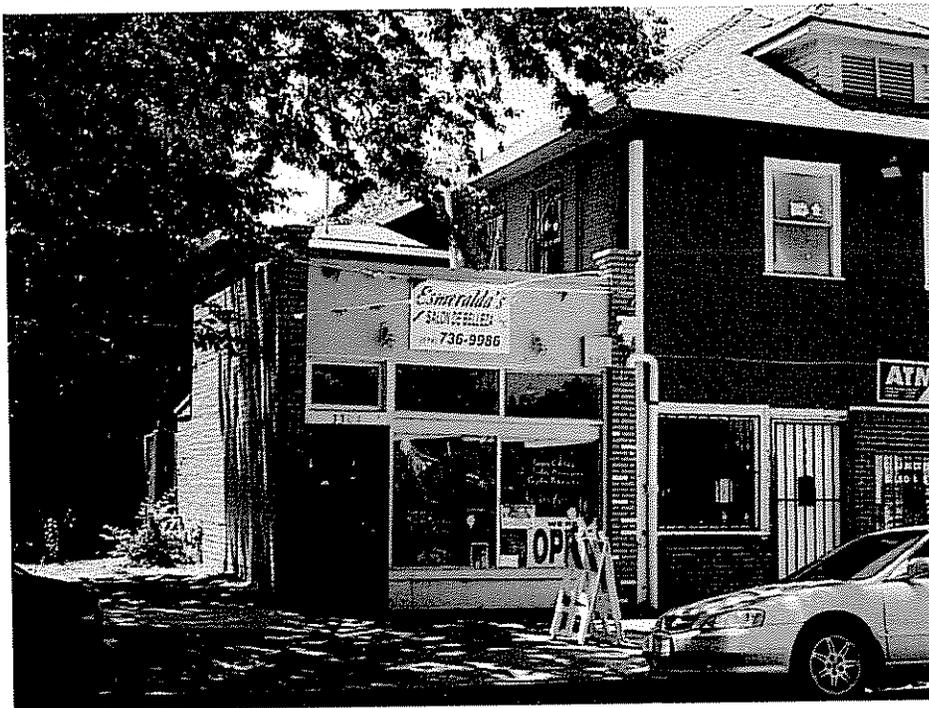
The door may have originally contained glass or glass panels. The space above the show windows may have been slightly modified to accommodate changes in the businesses that occupied the building. Metal protective grilles have been added to the show windows and door. A few of the tan bricks have been replaced on the west side of the façade.

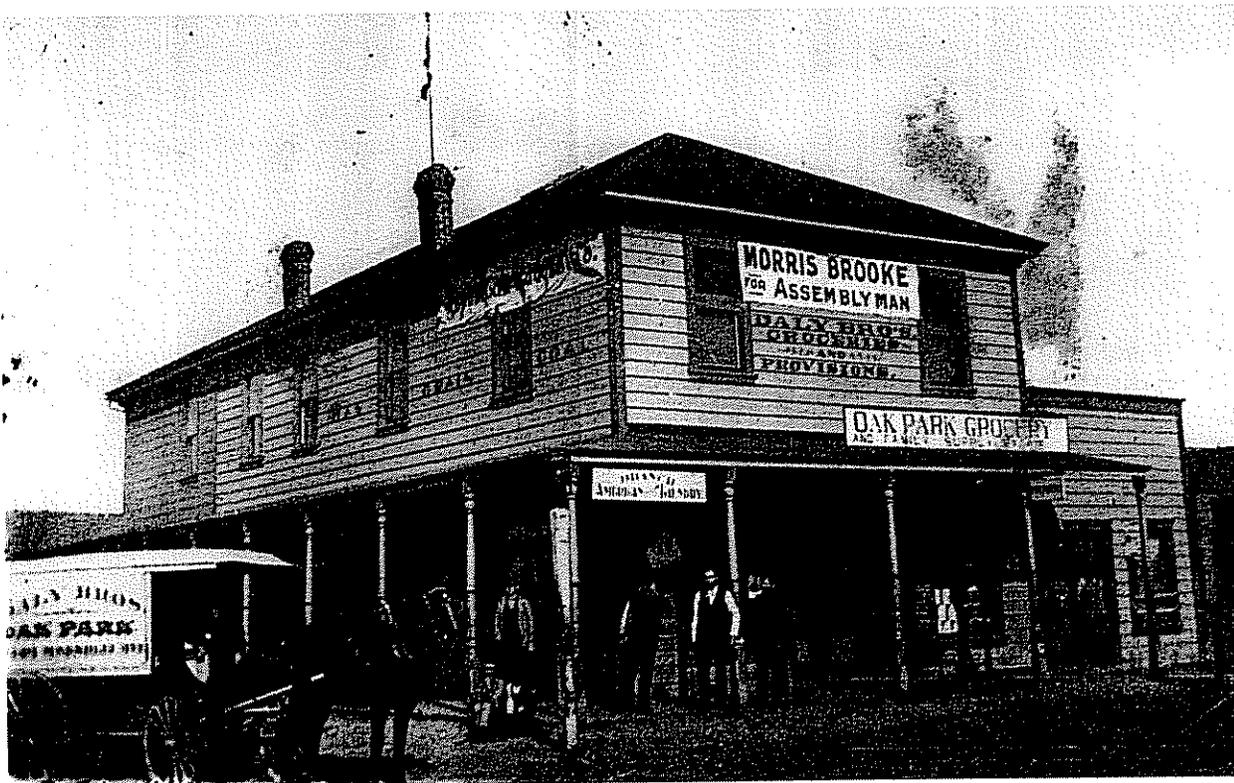
The Daly Brothers Oak Park Grocery, ca 1901. Notice that even the small single-story unit on the right (east) is still in place at the present time.

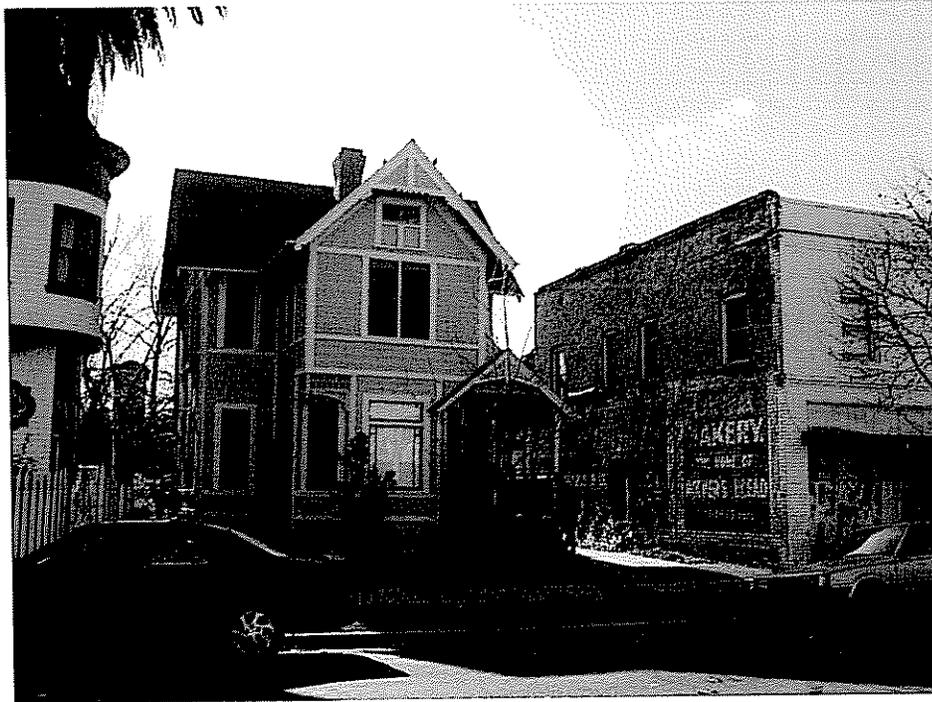
The house is currently being remodeled into offices for the Sacramento Philharmonic. It is hoped that the work will maintain the current historic fabric and that the original double-hung windows will be replaced and that other items that have been removed, such as the porch balusters, rails and front steps will be replaced with designs consistent with the house's era of construction.

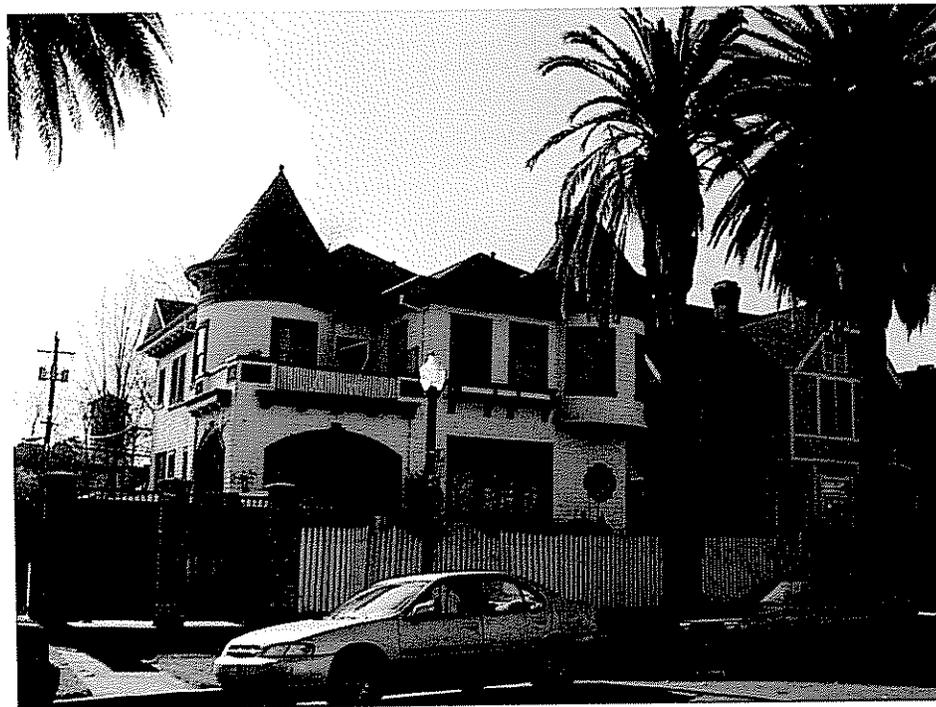
The house is composed of round and rectangular forms, with conical and hipped roofs. Two round Queen Anne towers flank the front of the building, one on the second floor west and a two-story one on the east. The northeast corner entrance contains two segmental arched openings surmounted by a balconied second floor deck. Aside from the Queen Anne tower friezes, stained glass panels and applied bas relief Balcony panels, the ornamentation is rather classical in derivation, with heavy eave and porch projection brackets, centered arch ornaments and oval widow next to the door, with its sidelights. A stained glass trefoil windows lies beneath the projecting second floor tower. The surface is shingled, and windows are double hung, except for the fixed, stained glassed-topped trio of the façade. Moldings are surfaced with a bas relief floral and circle pattern. Entry steps are marble.

Up to this point in its history, the building appears essentially unaltered. However, it was badly damaged during a fire in 2004 and was boarded up. It was rehabilitated with a high level of integrity.

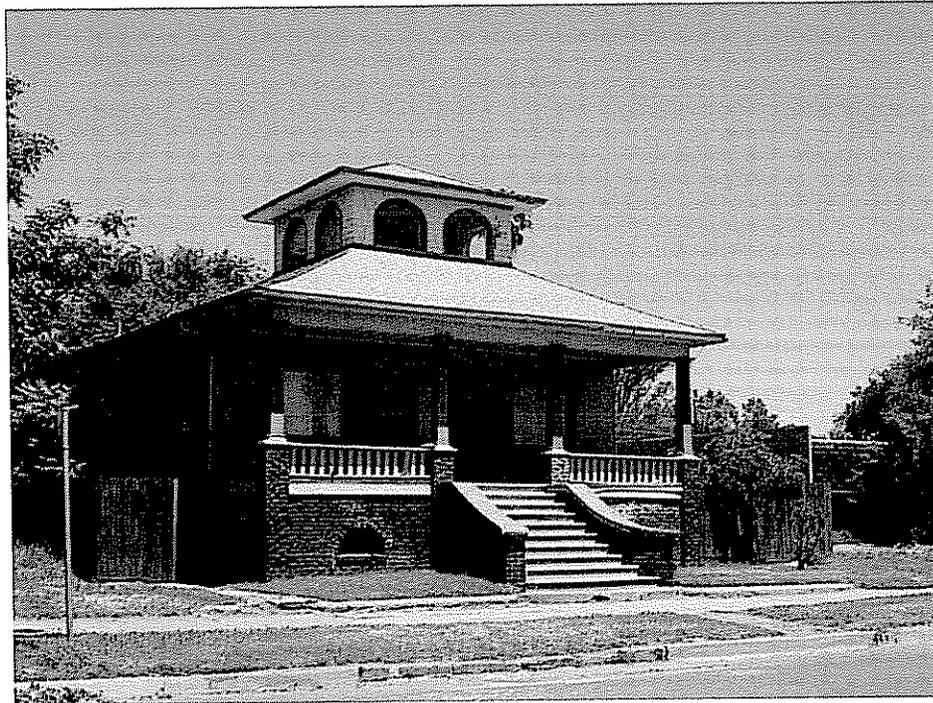
The wood frame house, almost square in form and with its distinctive second floor cupola, is an almost classic example of an "aeroplane" house form. Stylistically, it reflects Craftsman design elements with its clinker brick porch base and step sides, battered posts, and horizontal emphasis. Brick lined arches penetrate the clinker brick porch base. The staircase flares outward at the bottom. The hipped roof is topped by the projecting cupola. Narrow, three-tiered rustic drop siding surfaces the house while shingles surface the cupola with its oddly arched windows. An angled bay projects from the east elevation toward the rear of the house. A square bay projects from the western elevation.

P5b. Description of Photo:
View to the north

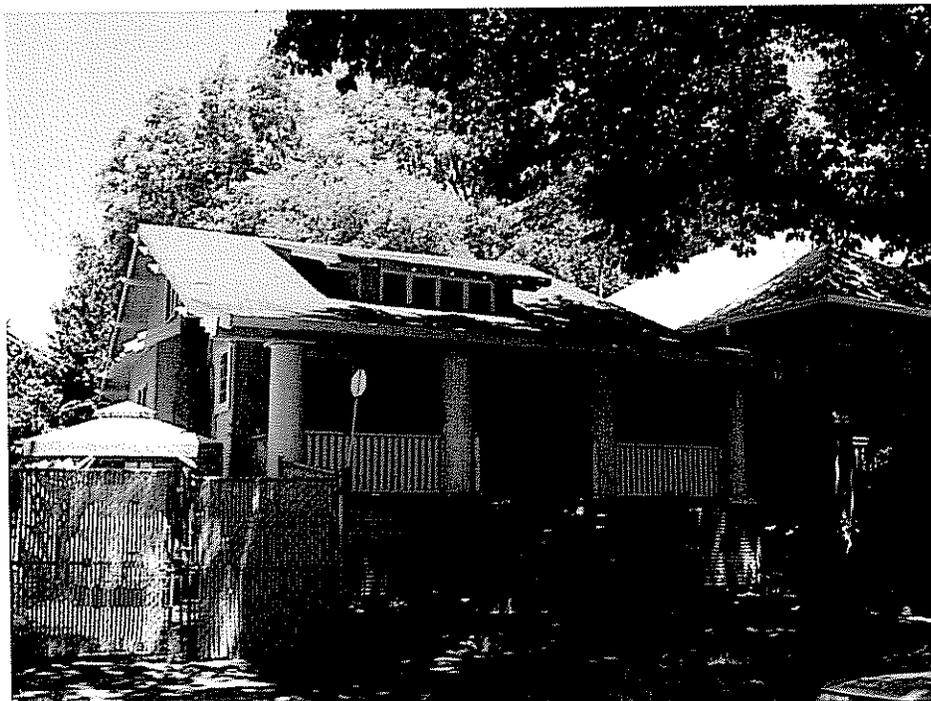
Balustrades with vertical wood slats connect the columns on either side of the stairway leading to the porch entry. The side-gabled roof contains a slanted dormer inset, with four framed windows. The building is sheathed in horizontal rustic wood siding, as is the base of the porch. The front door is flanked by sidelights. There is a brick chimney stack on the west side of the house.

P5b. Description of Photo:
View to the north.

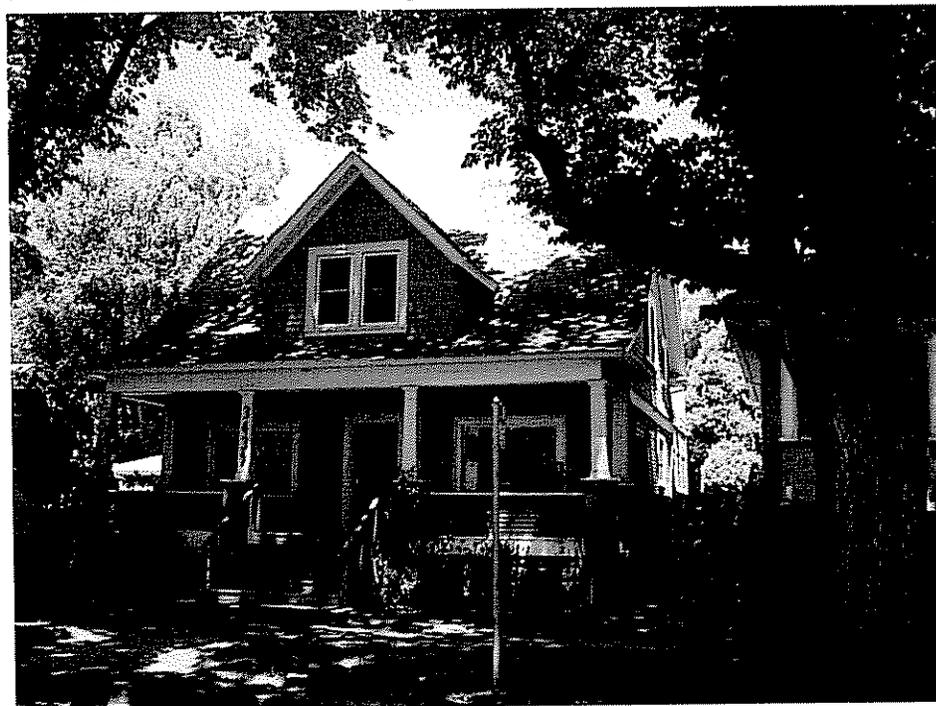
The wood frame residence is one story with a raised basement. The roof is gabled parallel to the street with a large gabled dormer projecting toward the street. The dormer contains a pair of rectangular one light over one, wood-sash windows, framed with simple molding. Window openings on the main floor are also enframed with similar molding. The porch roof is an extension of the side-gabled roof and is supported by squared posts with square capitals. The building is surfaced with rustic tiered horizontal lap siding. The base of the building is of rusticated concrete block, designed to appear as stone courses. Balustrades are angled slats, in a pattern of narrow and wide. Stylistically, the building employs Colonial Revival and Craftsman design influences.

Alterations include a one story addition on the west elevation with an additional side entrance, 3435 4th Avenue. A rear deck at the second floor is not original. Windows are double hung but replaced with metal sash.

P5b. Description of Photo:
View to the north.
