WOOD DESTROYING PESTS AND ORGANISMS INSPECTION REPORT

Building No.	Street, City, Zip	3a. Structural Pest Control Report
54	Quay court (74-81), Sacramento, CA, 95831

54	Quay court (74-81), Sacramento, CA, 95831	05/30/06	212473
BUILDING NO.	STREET, CITY, STATE, ZIP	INSPECTION DATE	REPORT NO.

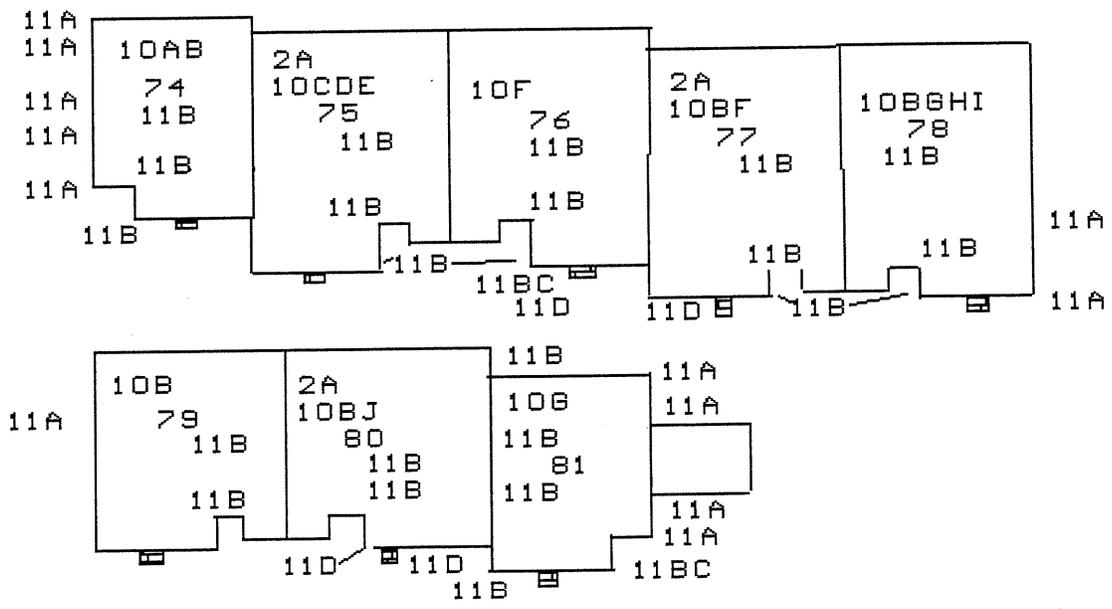
An inspection has been made of the structure(s) shown on the diagram in accordance with the Structural Pest Control Act. Detached porches, detached steps, detached decks and any other structures not on the diagram were not inspected.		
Subterranean Termites <input type="checkbox"/> Drywood Termites <input type="checkbox"/> Fungus/Dryrot <input checked="" type="checkbox"/> Other Findings <input checked="" type="checkbox"/> Further Inspection <input checked="" type="checkbox"/> If any of above boxes are checked, it indicates that there were visible problems in accessible areas. Read the report for details on checked items.
